HVAC Air Handling Unit (AHU) Restoration

HVAC Restoration Process: The Sustainable Solution

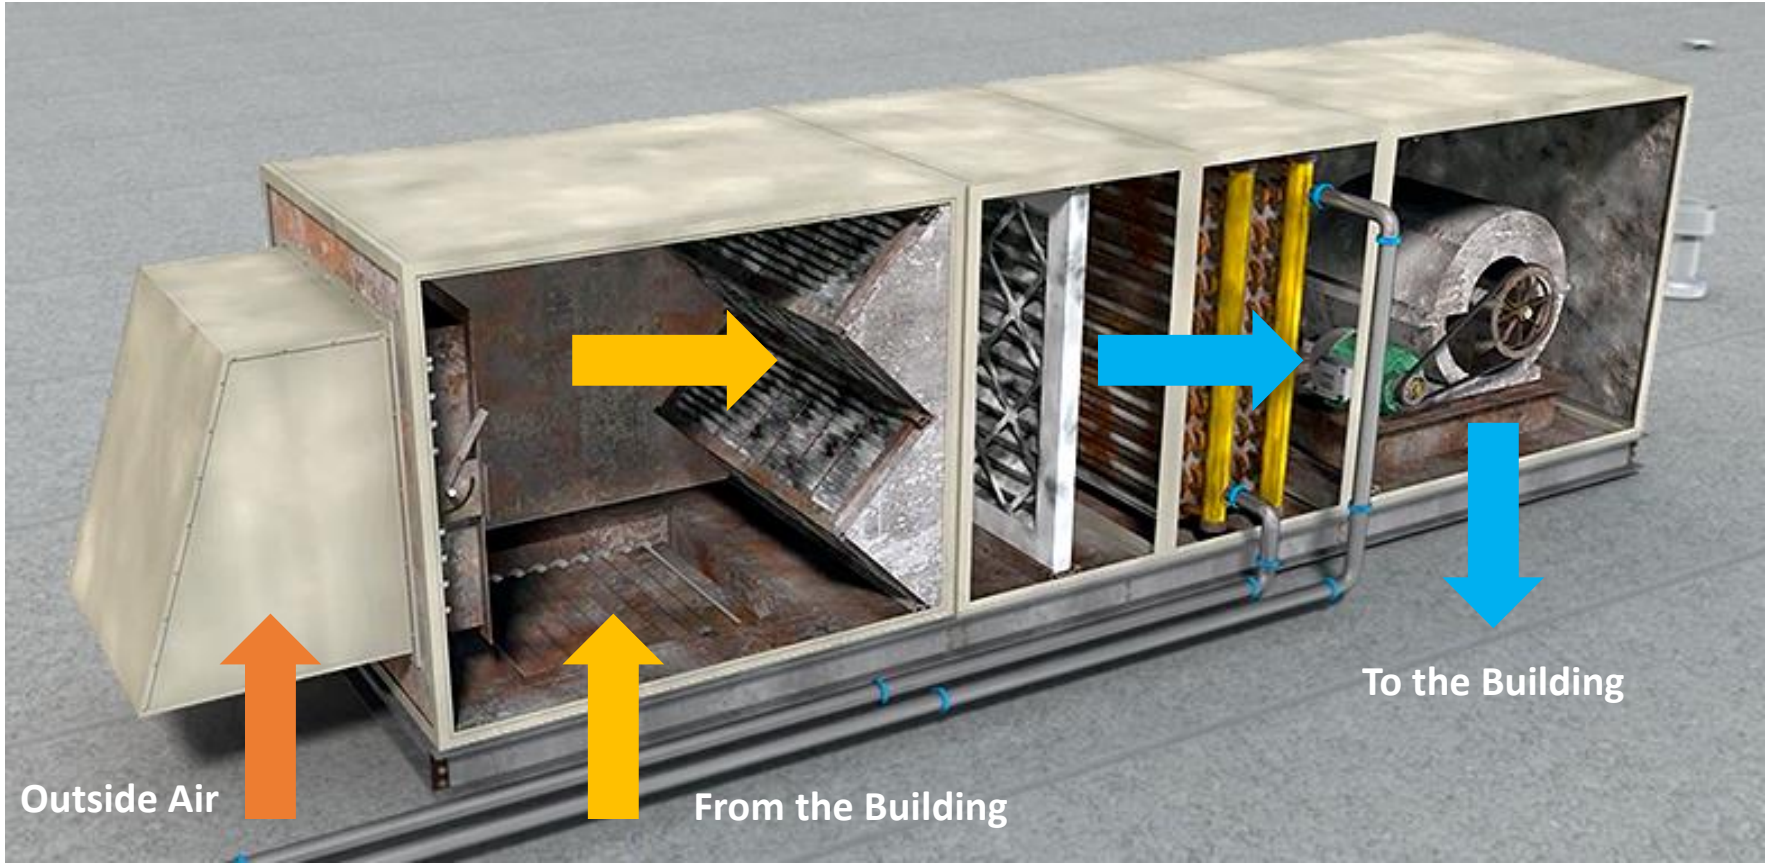
Anatomy of a CHW/HHW Air Handler Unit (AHU)

Fresh Air and Return Side

Supply Side

To the Building

Outside Air

From the Building

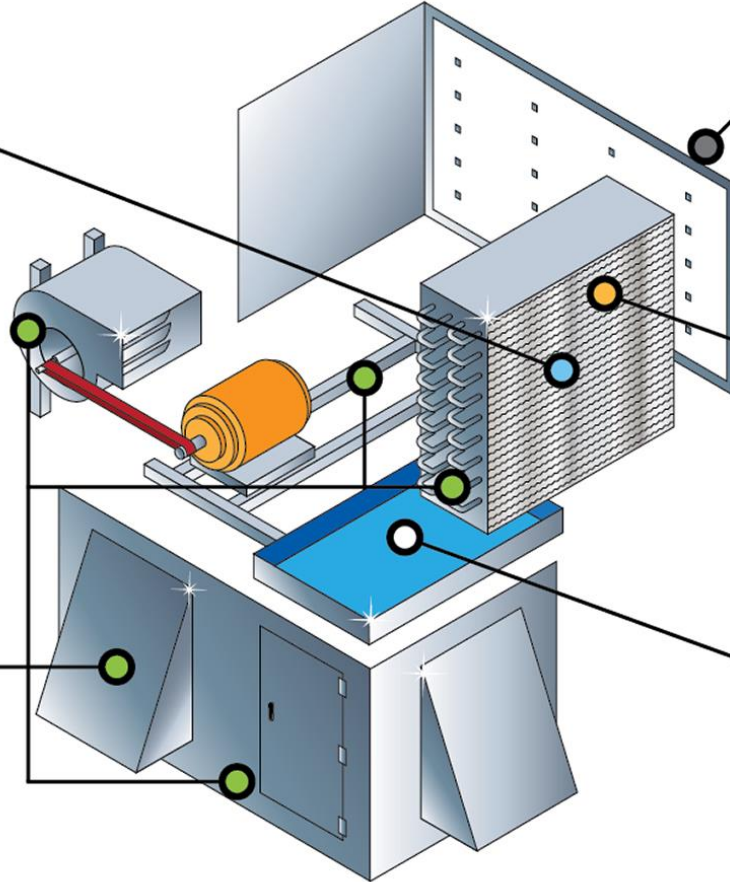
PURE-*Steam*™

HVAC Hygienic Cleaning

- Disinfects Coils at up to 350° F & 350 psi
- Optimizes Airflow & Static Pressure
- Improves Energy Efficiency

ECM Fan Array Retrofit

- Built-in Redundancy
- No More Belts or Grease

PURE-*Coat*

Multicoat Siloxane Coating

- Anti-viral, Anti-microbial & Corrosion Resistant
- 10,000 Hour ASTM B-117 Salt Spray Test Certificate
- Low VOC Application

PURE-cell

HVAC Insulation System

- Zero-Porosity
- Fiberglass Free
- Repels Moisture

PURE-*liner* 2.0

Drain Pan Protection

- Anti-viral, Anti-microbial & Corrosion Resistant
- Exceeds ASTM E84 NFPA 25/50 Standards
- Low VOC Application

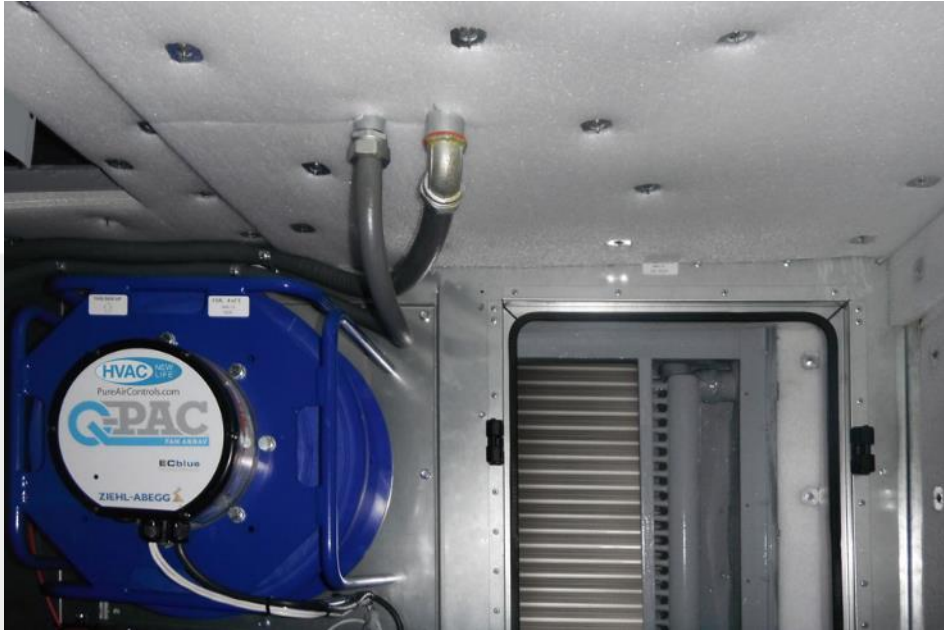
HVAC Fan Array

- Simple, Complete Retrofit
- ECM Fans
- Bulkhead/Array Assembly
- Single Point Power
- No VFD's, Grease or Belts
- Built-In Redundancy
- Access doors and dampers engineered as needed

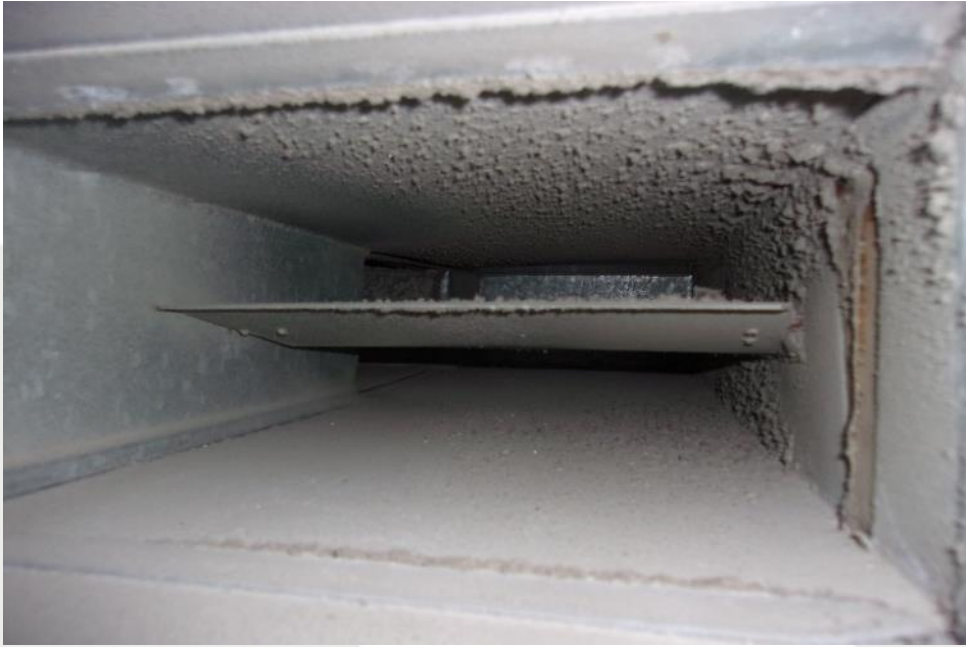
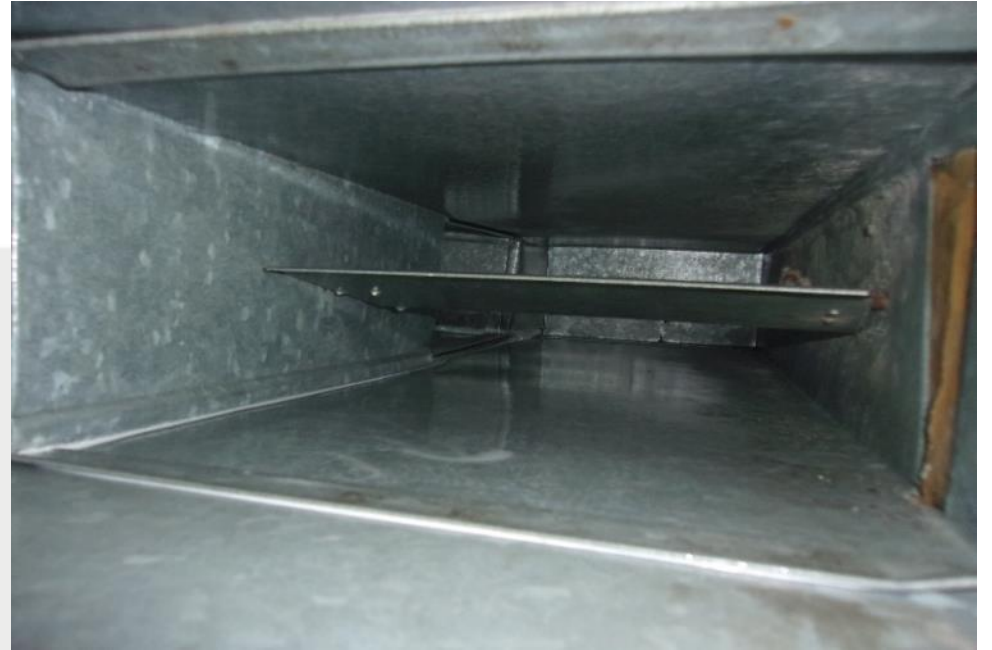
HVAC Restoration: Environmental Duct Cleaning

BEFORE

AFTER

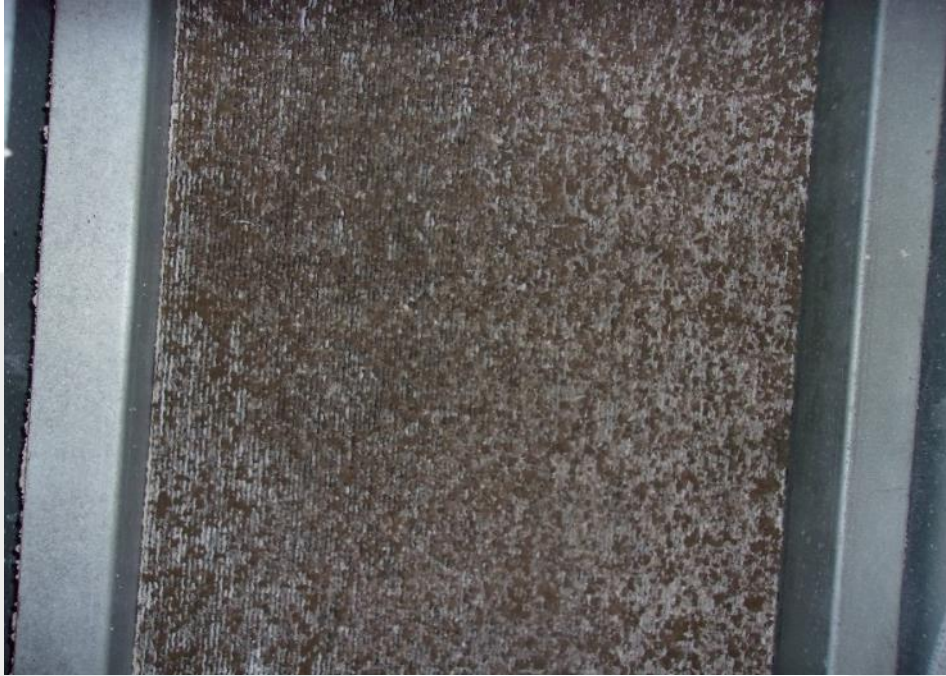
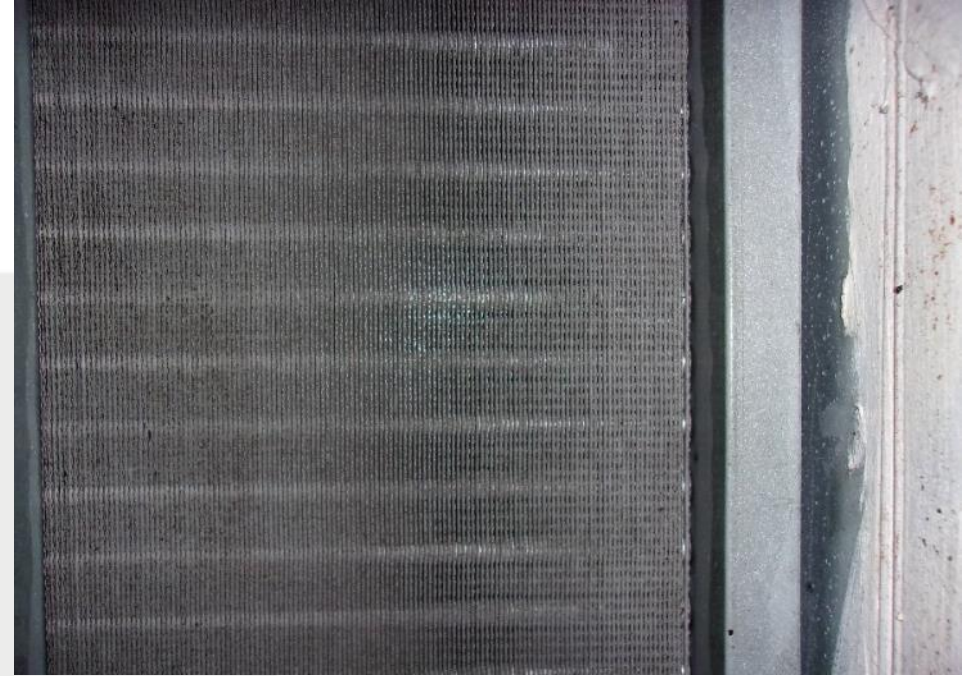
HVAC Restoration: Environmental Duct Cleaning & Encapsulation

BEFORE

AFTER

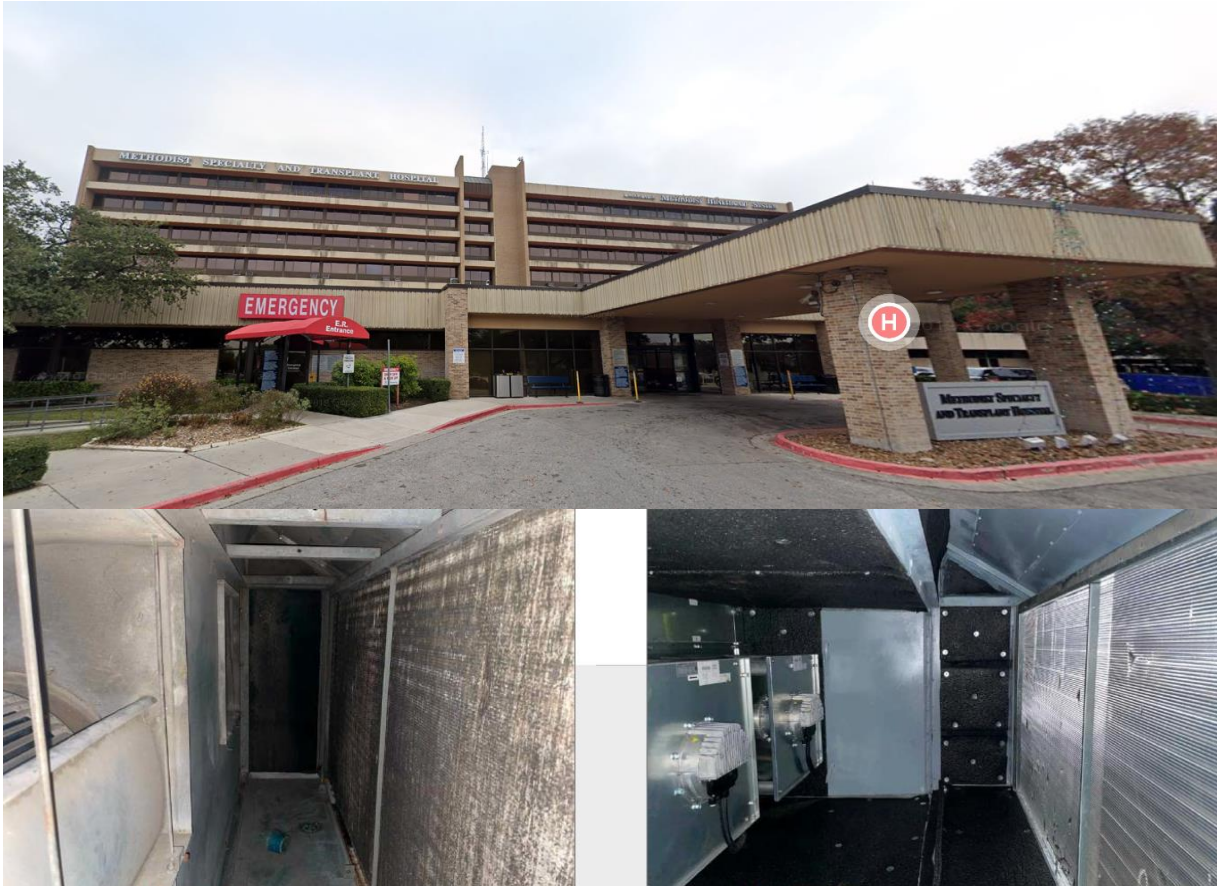
AHU 1 and AHU 12 Restoration

- Both units serve ORs
- HVAC Restoration:
 - ✓ Steam Cleaning
 - ✓ Interior Coatings and metal work
 - ✓ Exterior Coatings and metal work
 - ✓ PURE-Cell Insulation
 - ✓ Fan Array
 - ✓ Long-range capital plan (25) HVAC units

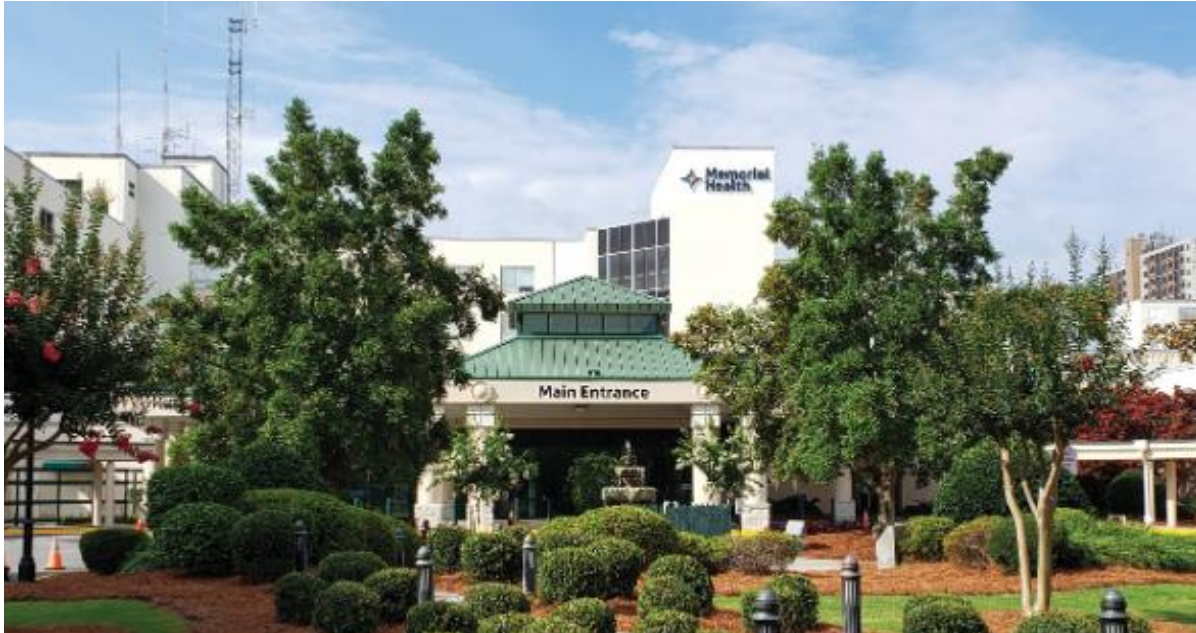
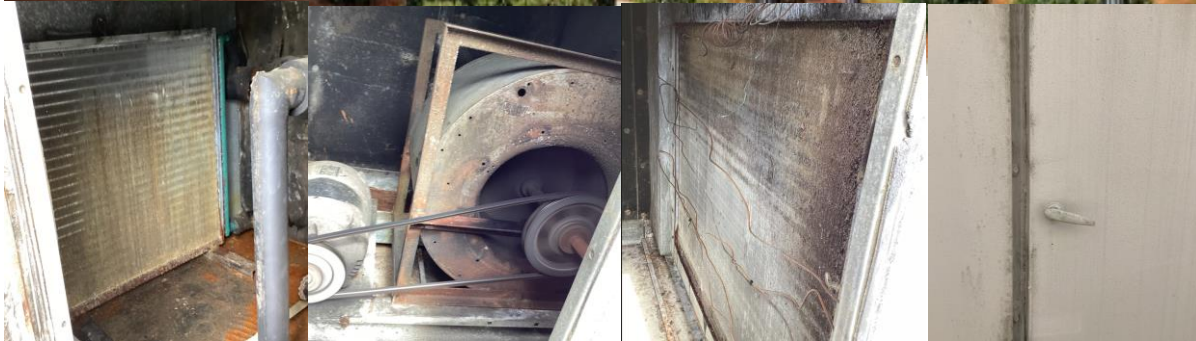
AHU 1 Restoration

- Unit serves administrative areas - 5,000 CFM RTU
- HVAC Restoration:
 - ✓ Steam Cleaning
 - ✓ Pure-Liner Drain Pan Protection
 - ✓ PURE-Cell Insulation
 - ✓ Interior Coatings
 - ✓ Fan Array
 - ✓ Interior Coatings
 - ✓ Fan Array
 - ✓ New Coil
 - ✓ Replace door gaskets
 - ✓ Replace intake section

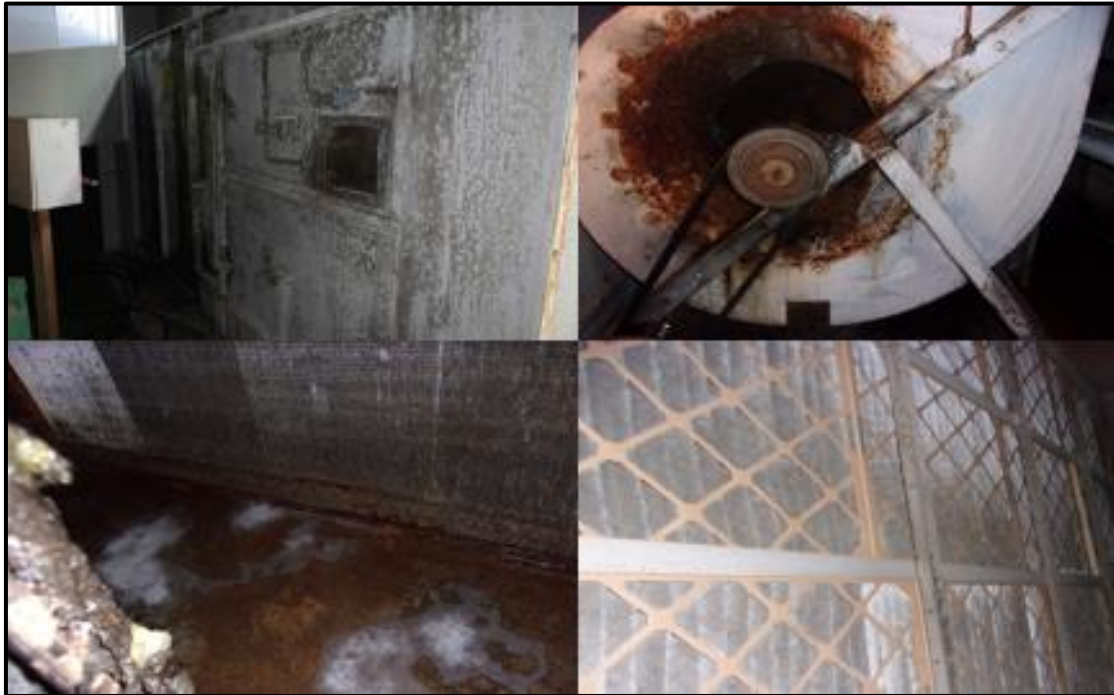
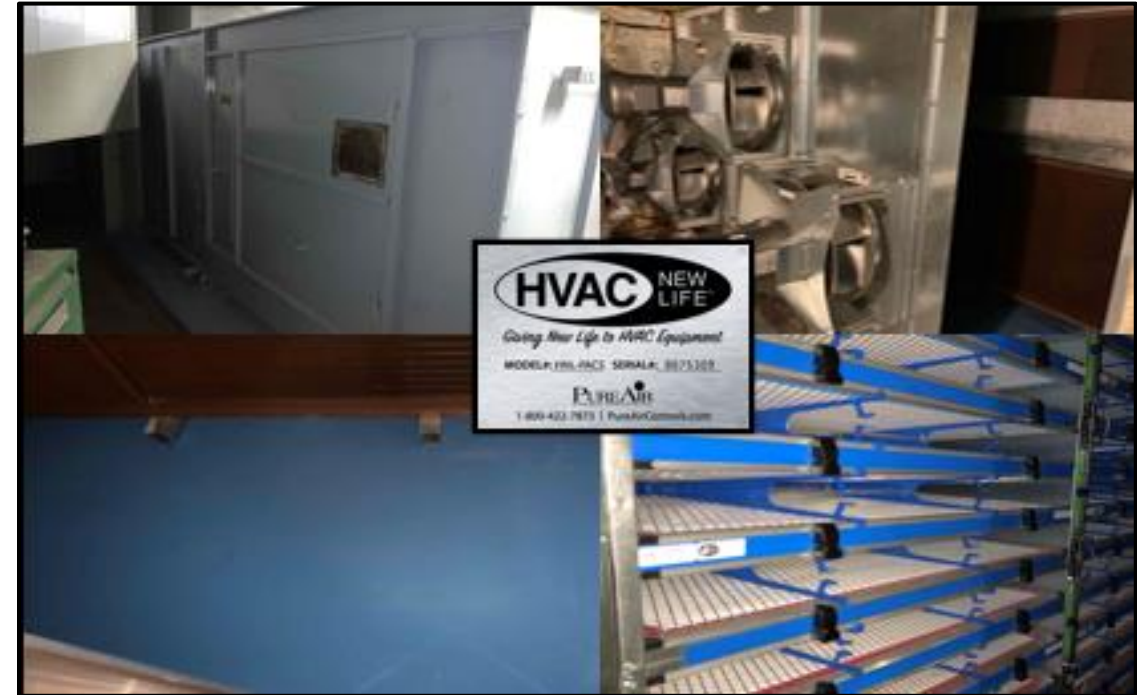
HVAC Restoration: AHU #131, AHU #141, AHU #151

- ✓ High Performance Cabinet Coating
- ✓ Fan Array Retrofit Installation
- ✓ Drain Pan Coating
- ✓ Upgraded Filtration System
- ✓ New HVAC Model + Serial Number

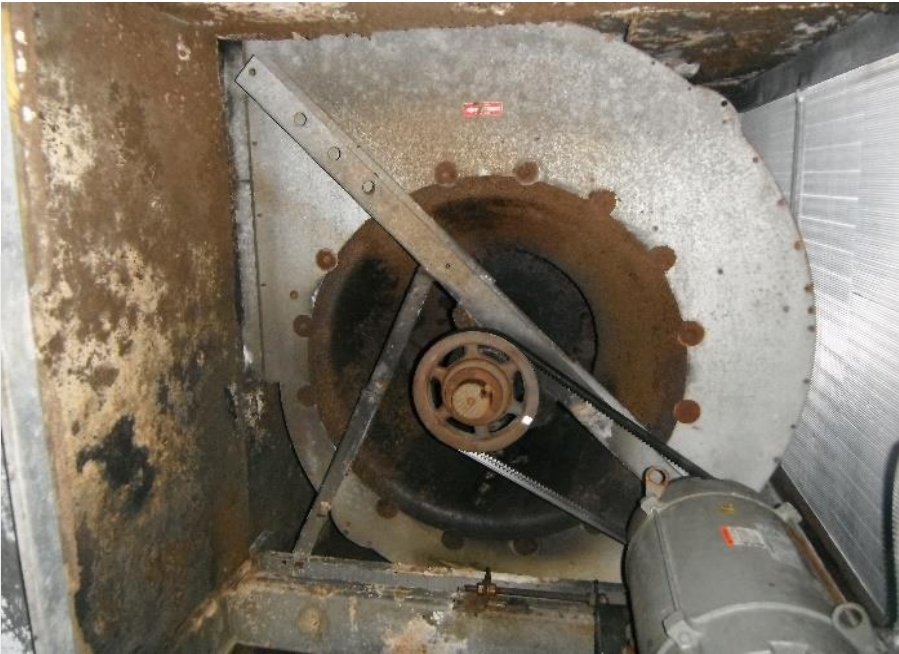
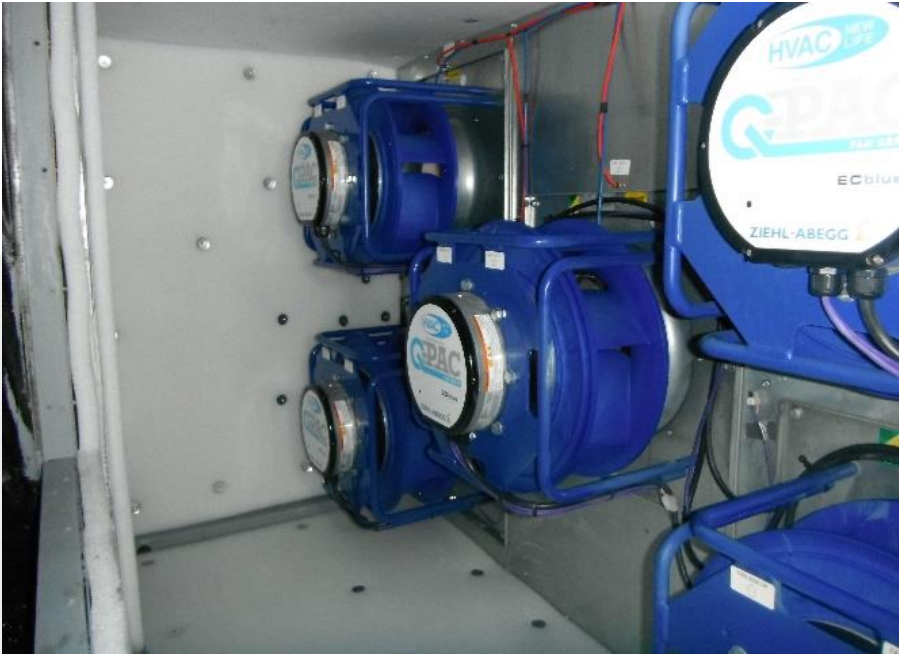
HVAC Restoration: Fan Array Retrofit

BEFORE

AFTER

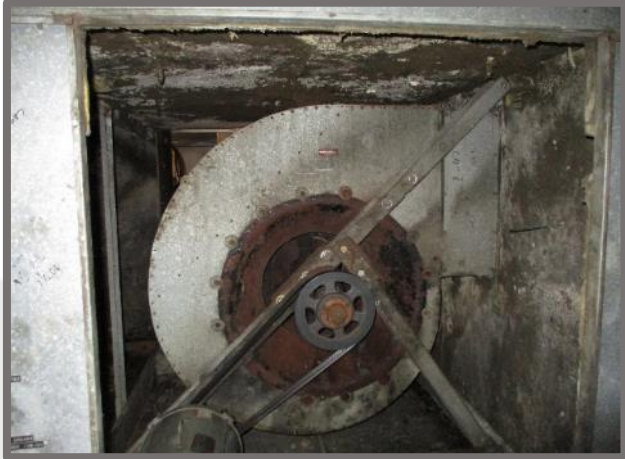
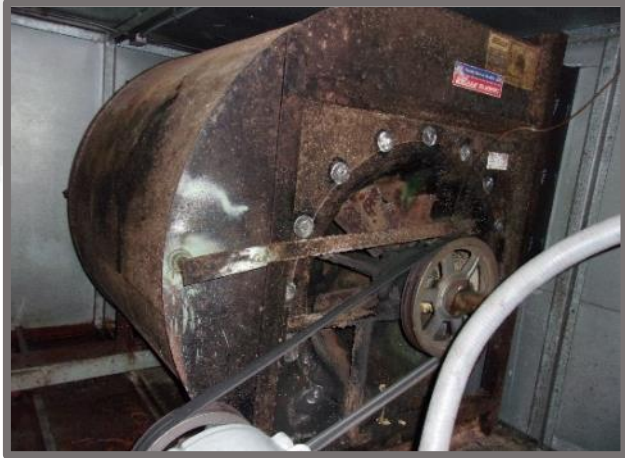
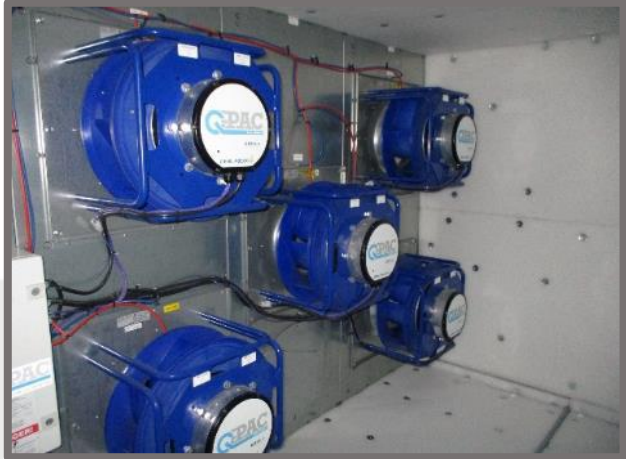
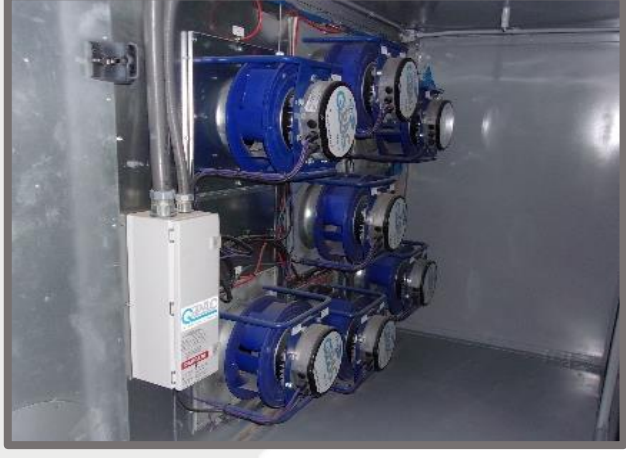
HVAC Restoration: Fan Array Retrofit

BEFORE

AFTER

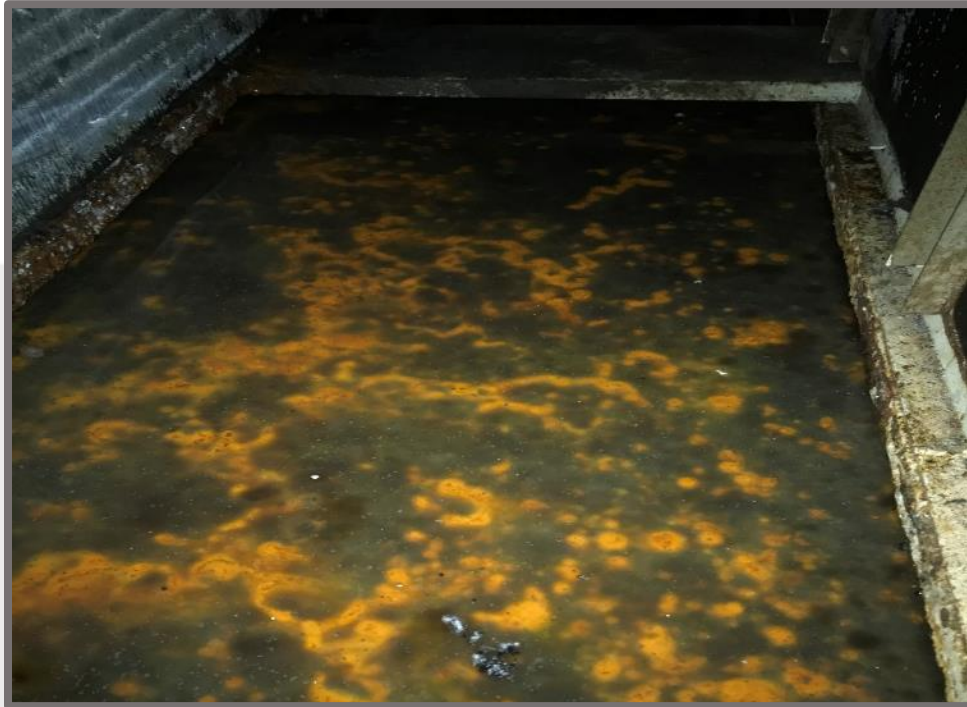
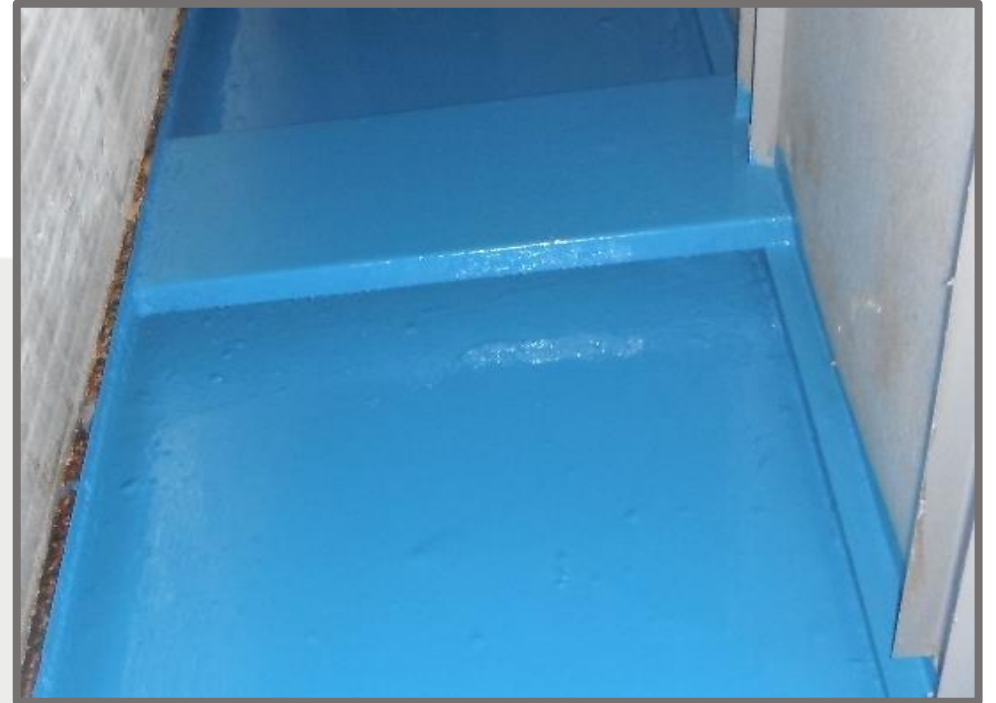
HVAC Restoration: High Performance Coatings

BEFORE

AFTER

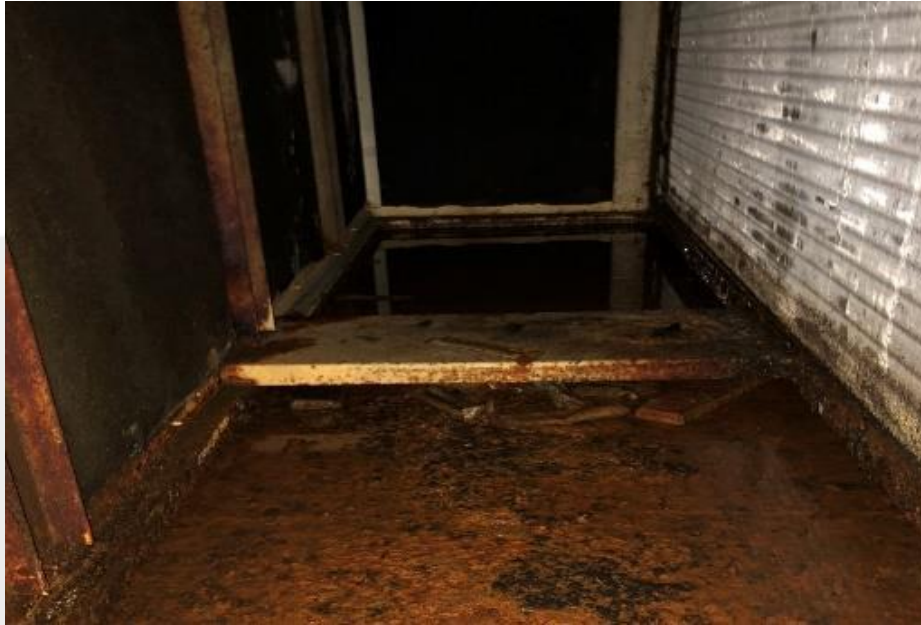
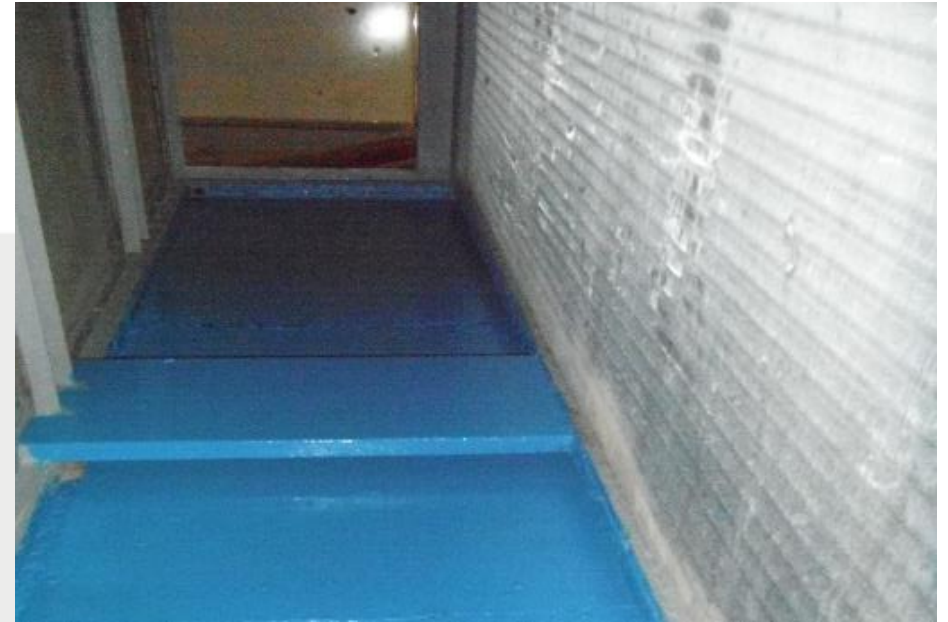
HVAC Restoration High Performance Coatings

BEFORE

AFTER

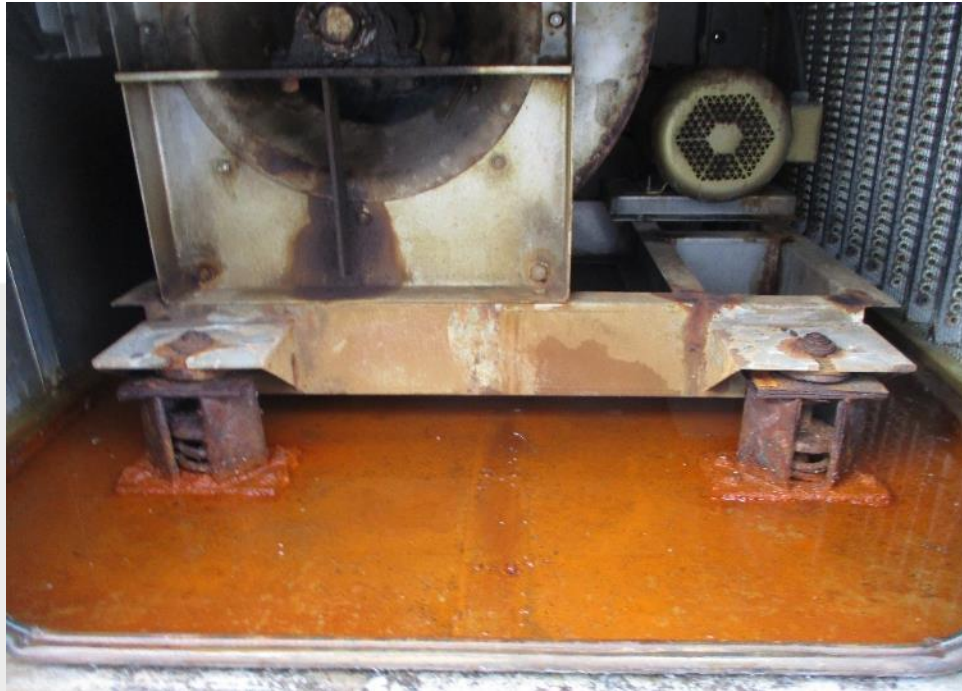
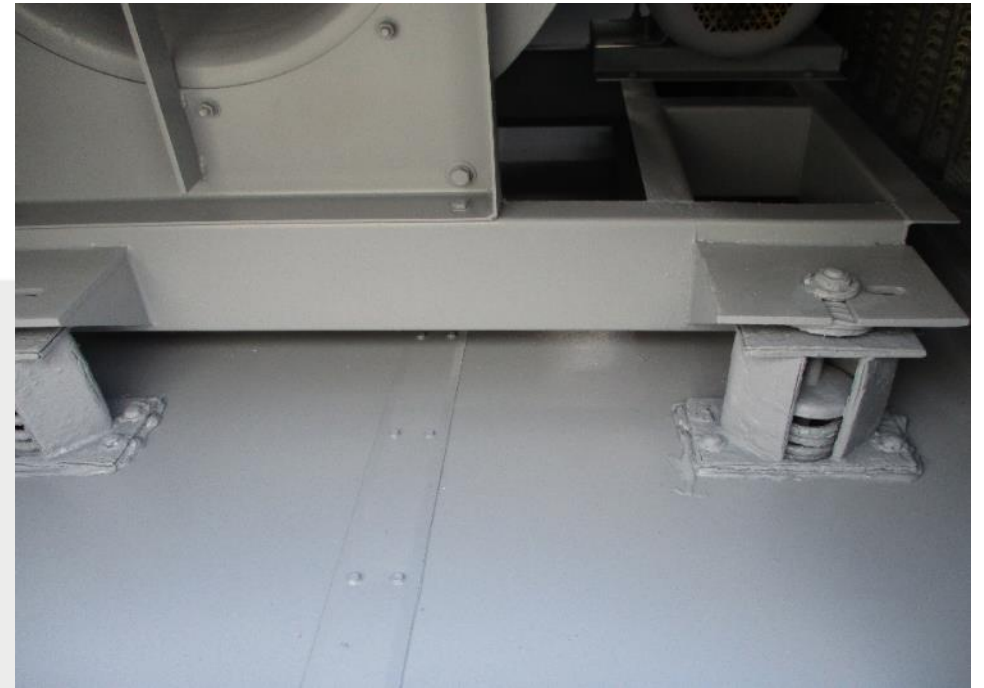
HVAC Restoration: High Performance Coatings

BEFORE

AFTER

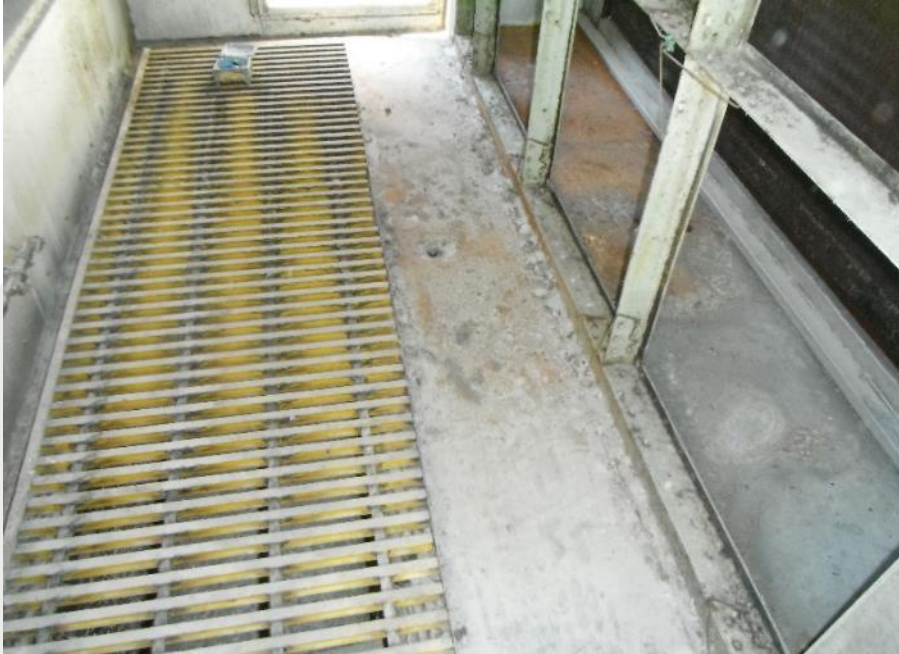
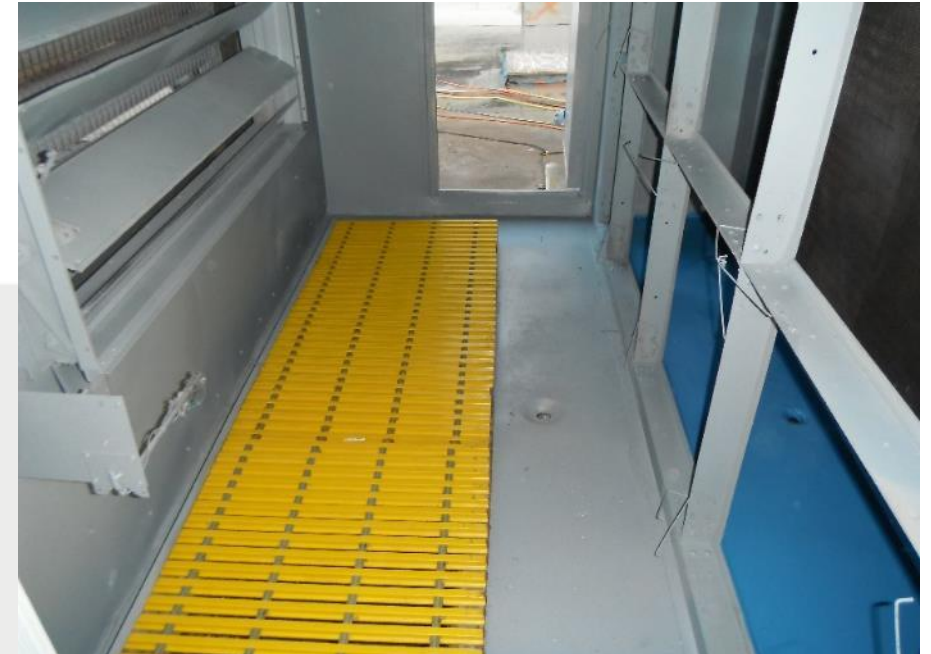
HVAC Restoration: High Performance Coatings

BEFORE

AFTER

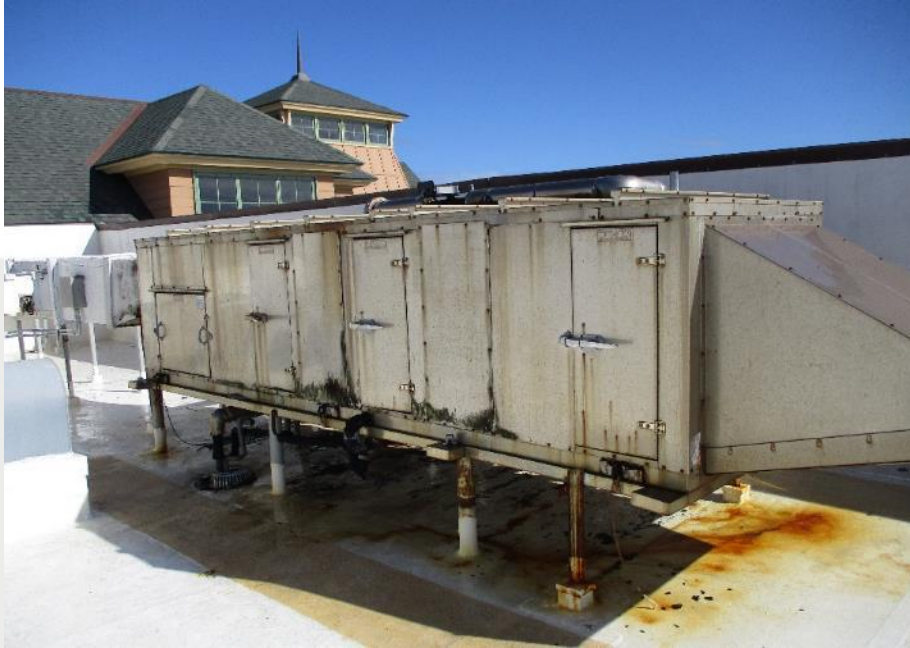
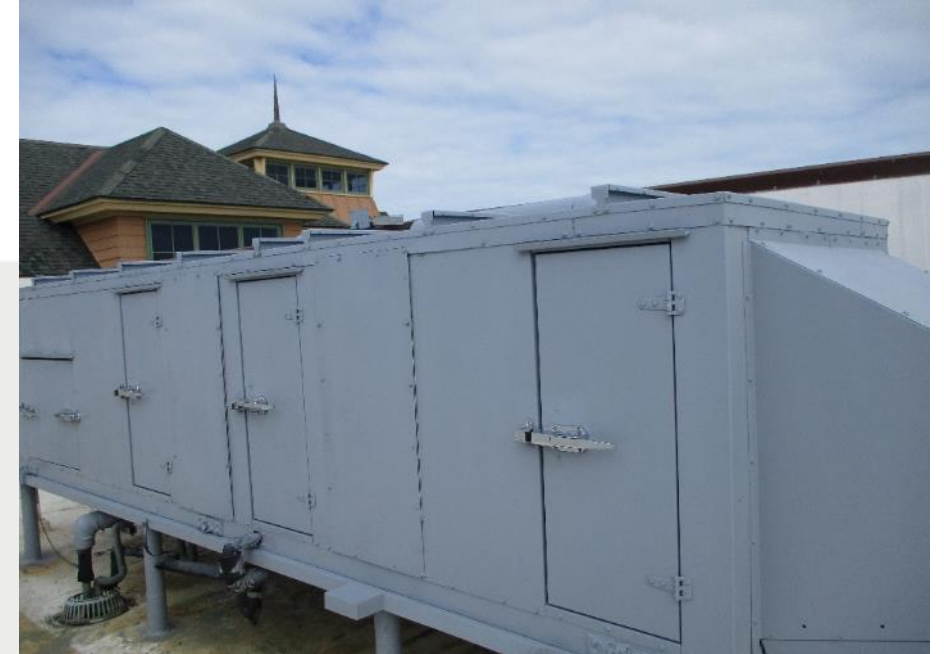
HVAC Restoration High Performance Coatings

BEFORE

AFTER

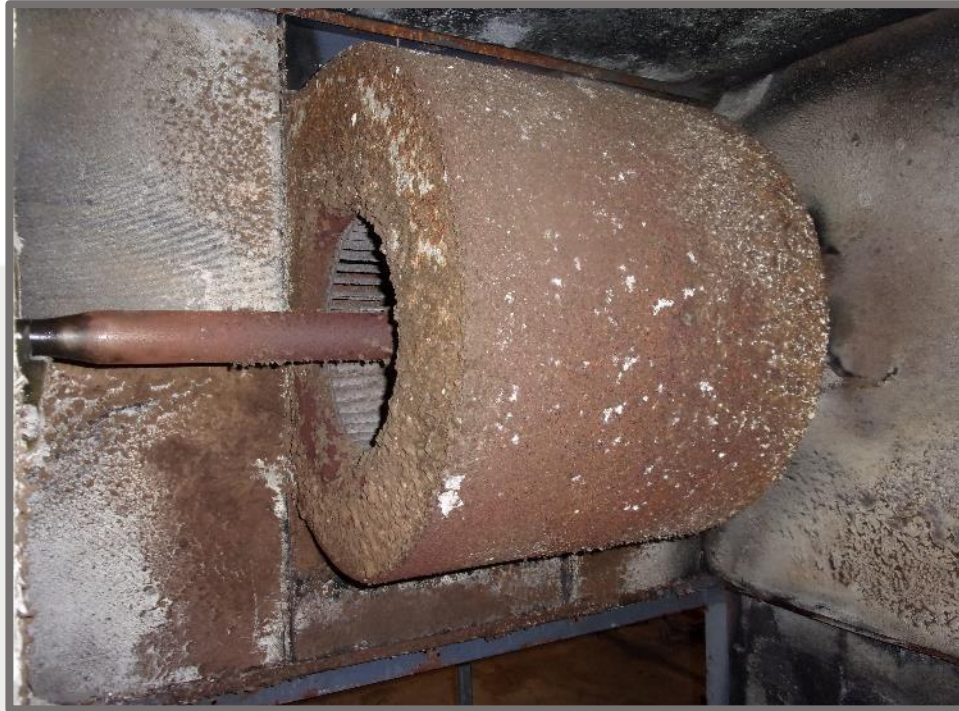
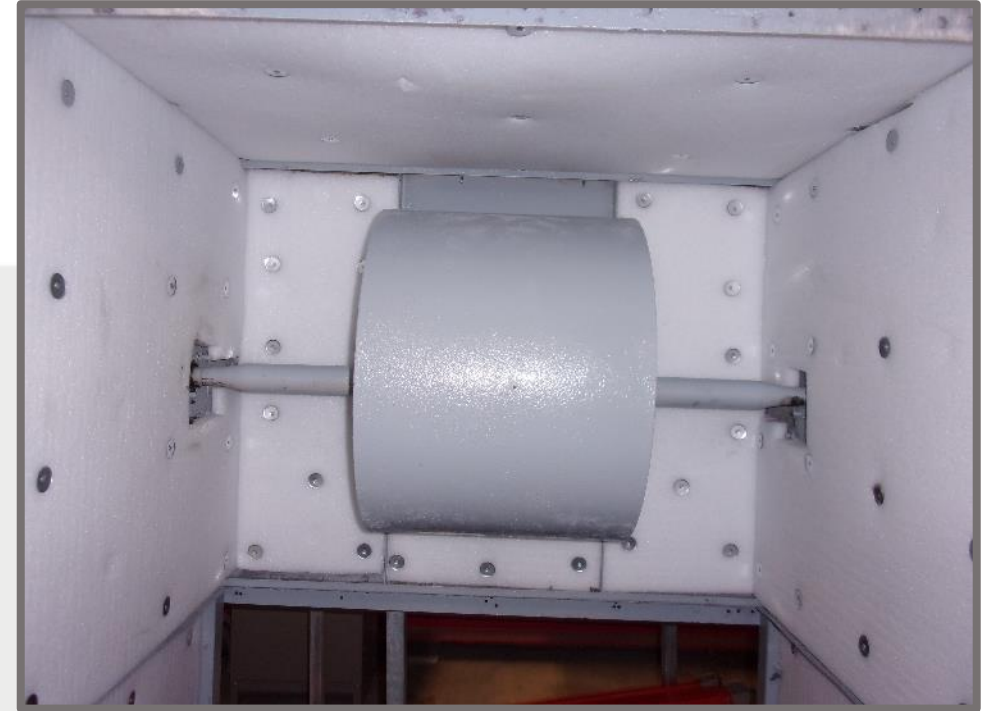
HVAC Restoration: Coating and Insulation

BEFORE

AFTER

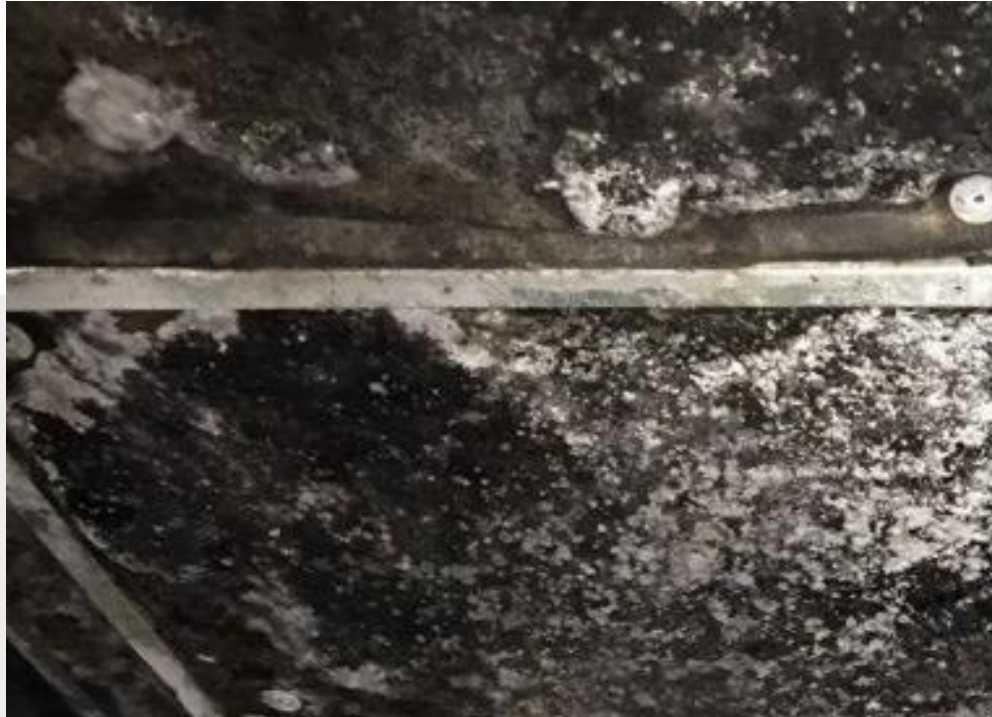
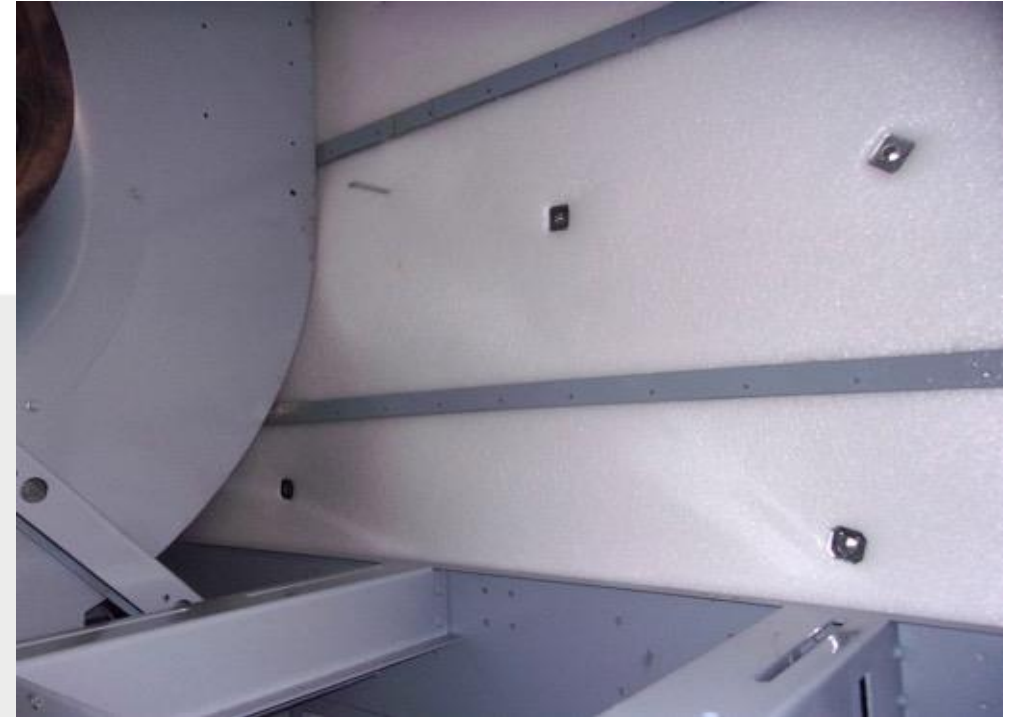
HVAC Restoration: Coating and Insulation

BEFORE

AFTER

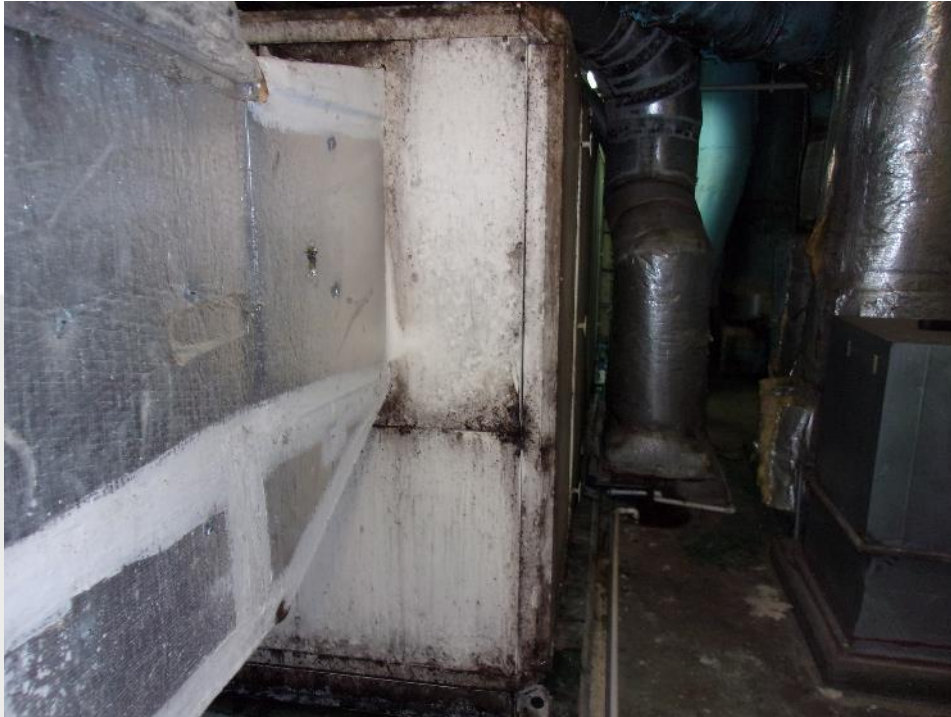
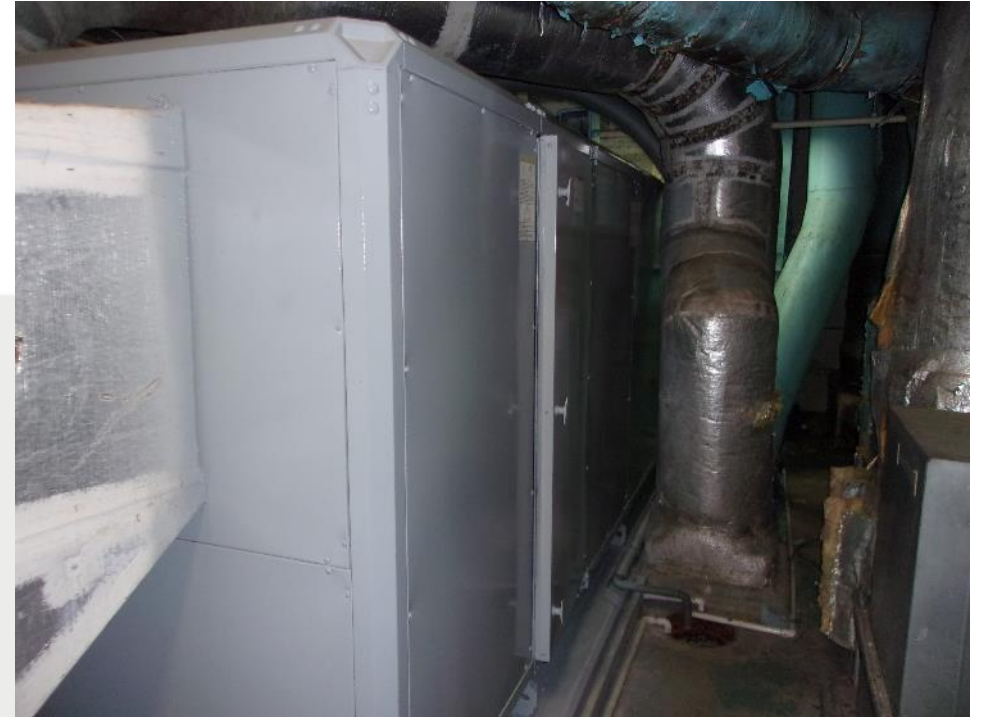
HVAC Restoration: Coating and Insulation

BEFORE

AFTER
