HVAC Air Handling Unit (AHU) Restoration

HVAC Restoration Process: The Sustainable Solution

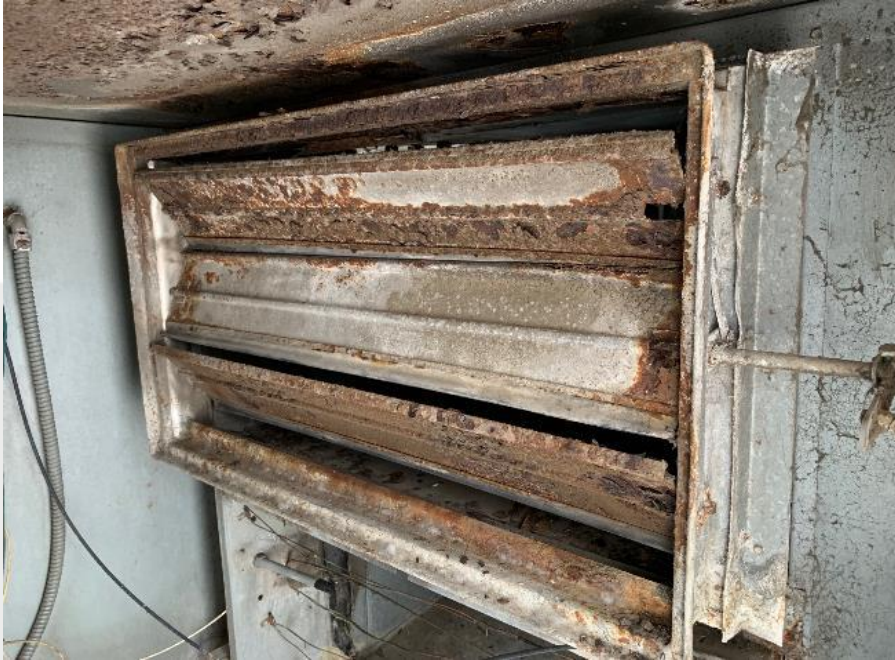
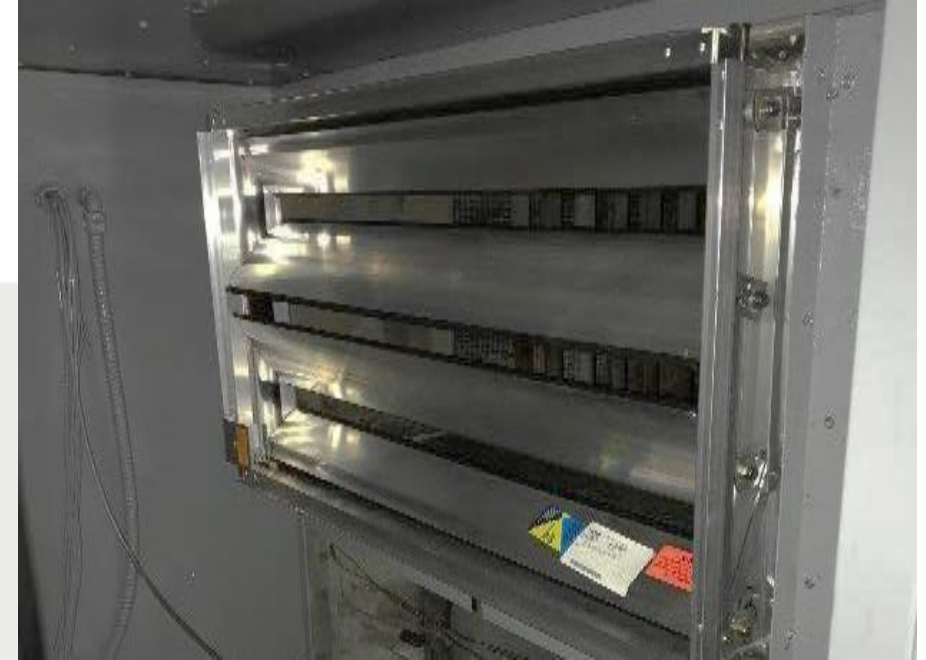
HVAC Restoration: Damper Retrofit

BEFORE

AFTER

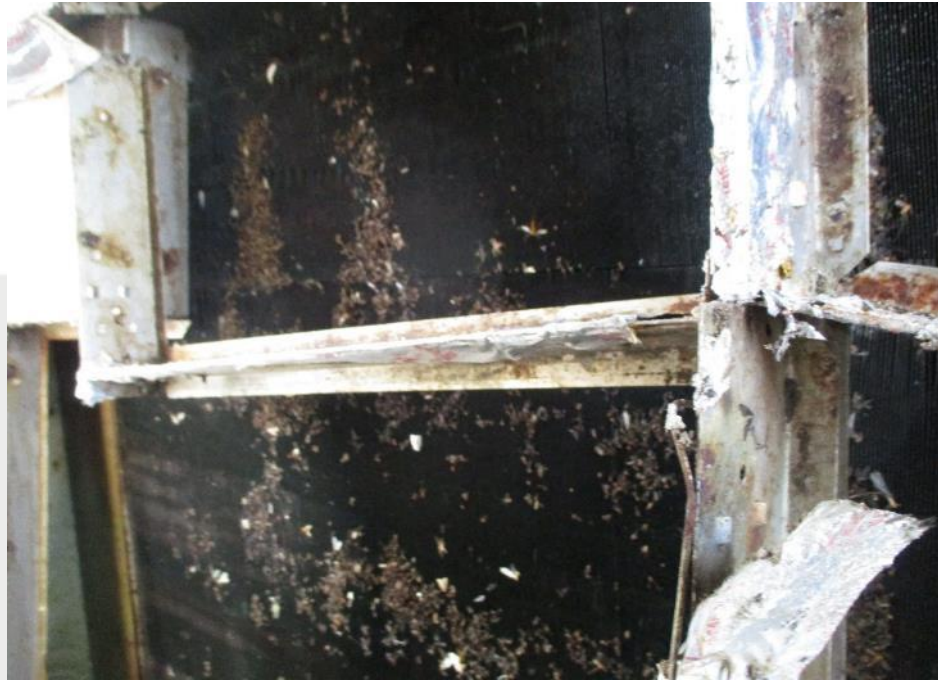
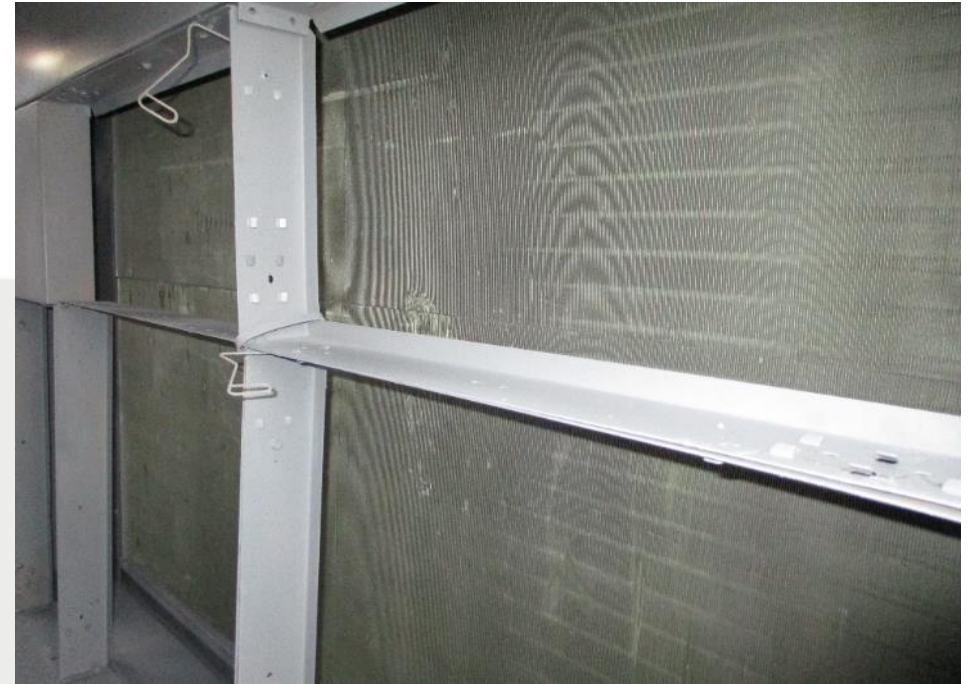
HVAC Restoration: Component Fabrication

BEFORE

AFTER
