Windows of Opportunity: Enhancing Building Owners' Strategies for Window Inspection and Maintenance

12 November 2024

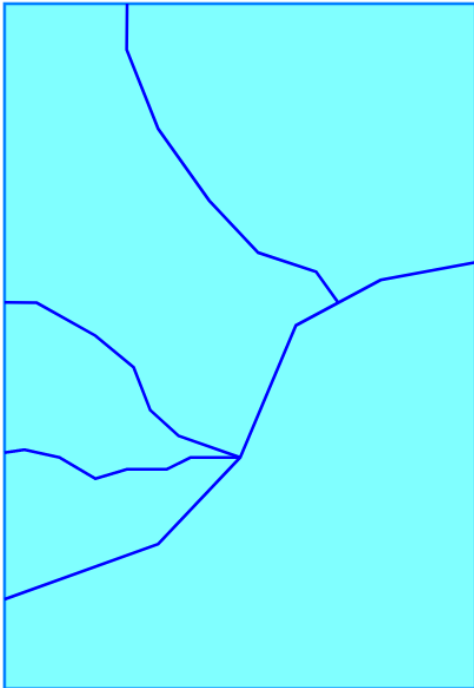
Annealed

Less than 3,500 psi

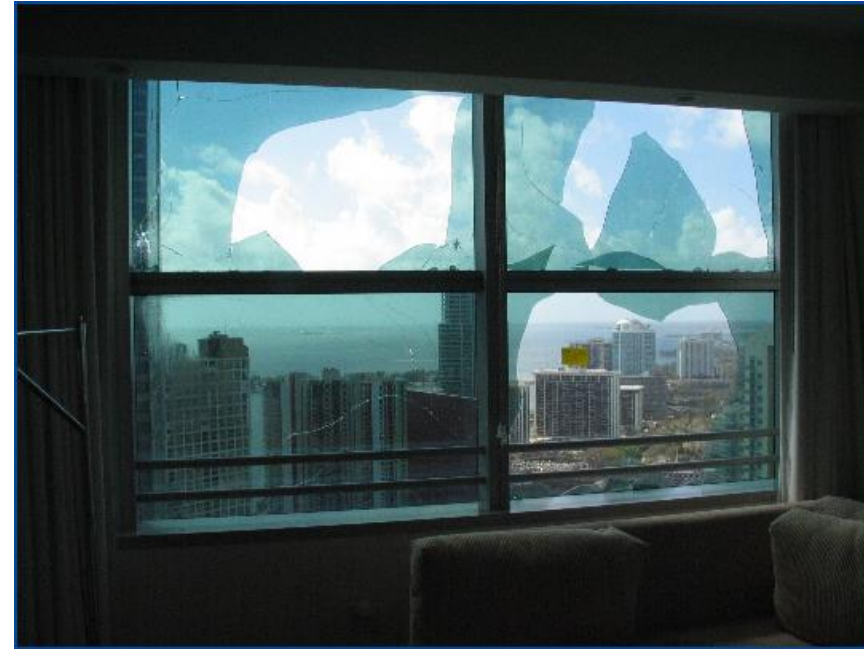
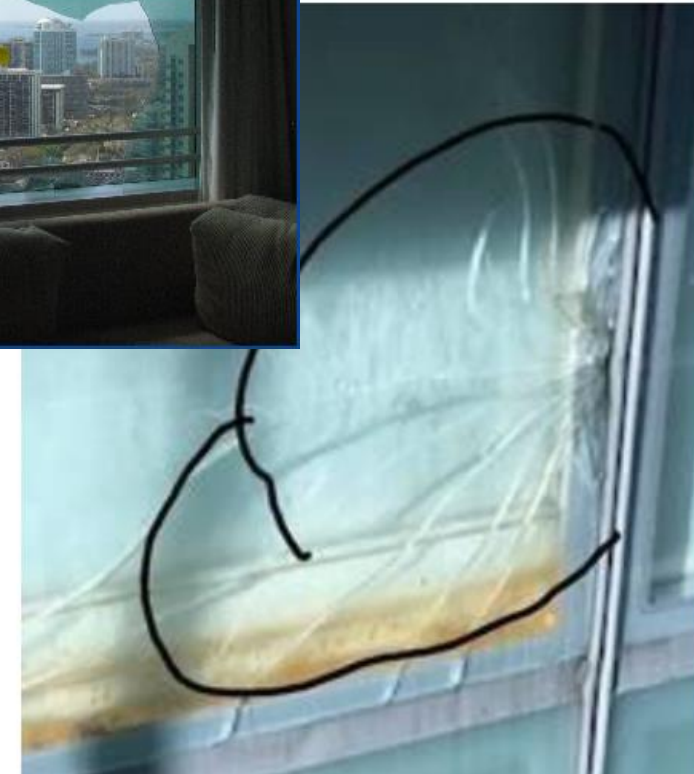
Cracking

- Cracking may result from multiple factors:
 - Impact
 - Edge flaws or defects
 - Thermal
- Size of glass shards varies based on the type of glass (annealed, heat strengthened, fully tempered)

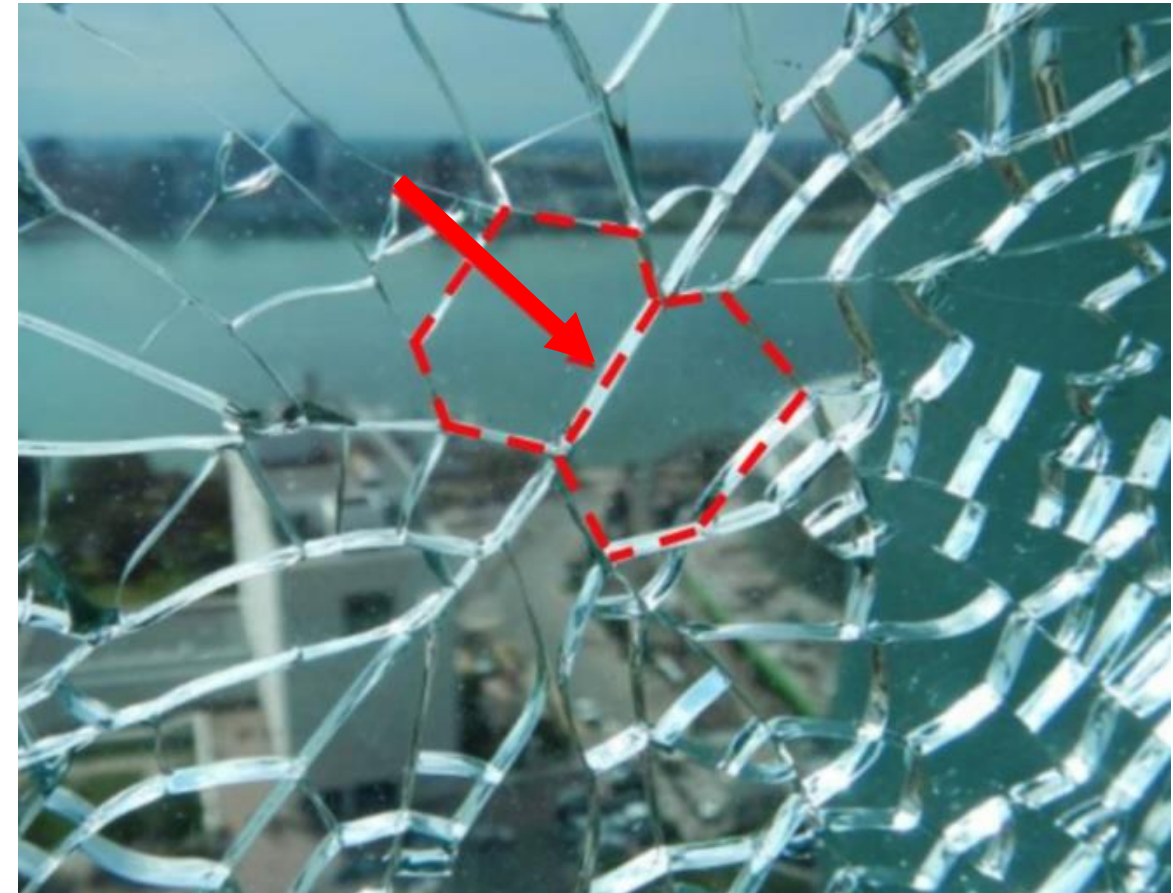
Nickle Sulfide (NiS) Induced Breakage

- Spontaneous breakage phenomenon in tempered glass only
- Predicting breakage is not feasible
- Distinct “cat-eye” origin
- Small black dot (NiS inclusion) at interface of origin
- Consider saving the origin for testing to confirm NiS

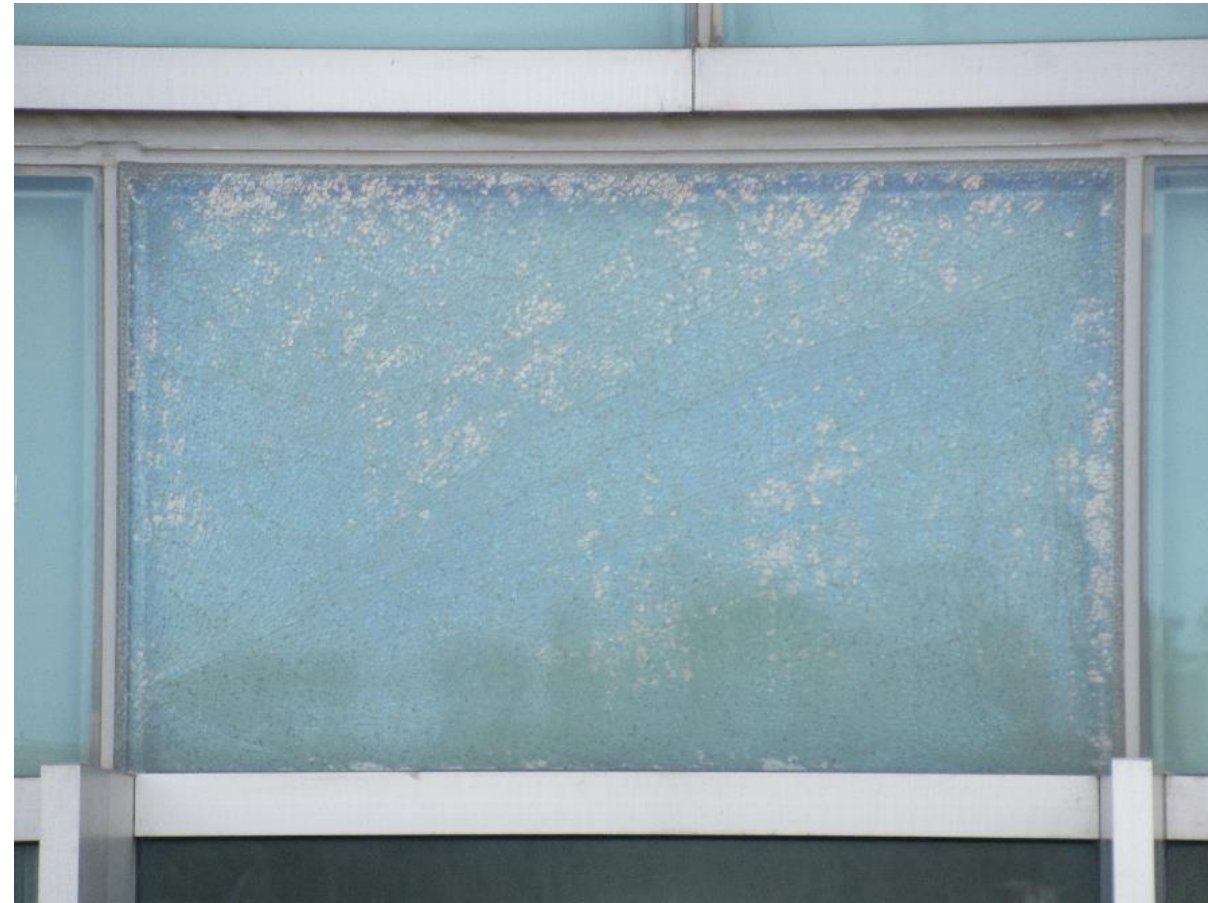
Hermetic Seal Failures

- Desiccant typically installed in the spacer bar absorbs moisture within the air space
- When the desiccant is spent (i.e., can no longer absorb moisture) may have condensation within air space
- In cold months, condensation may appear as frost.
- Low-e coating may corrode.

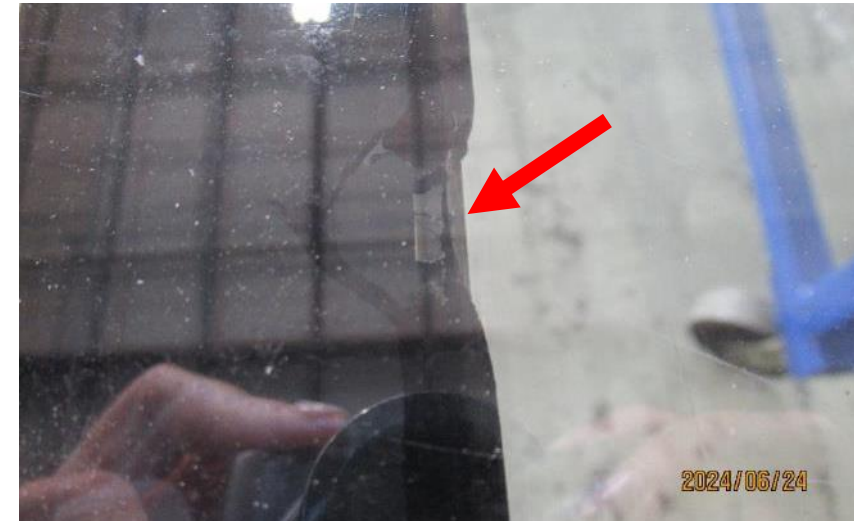
- Gaps in the secondary or primary sealant.
- Air exchange through the capillary tube

Gaps in
primary
sealant

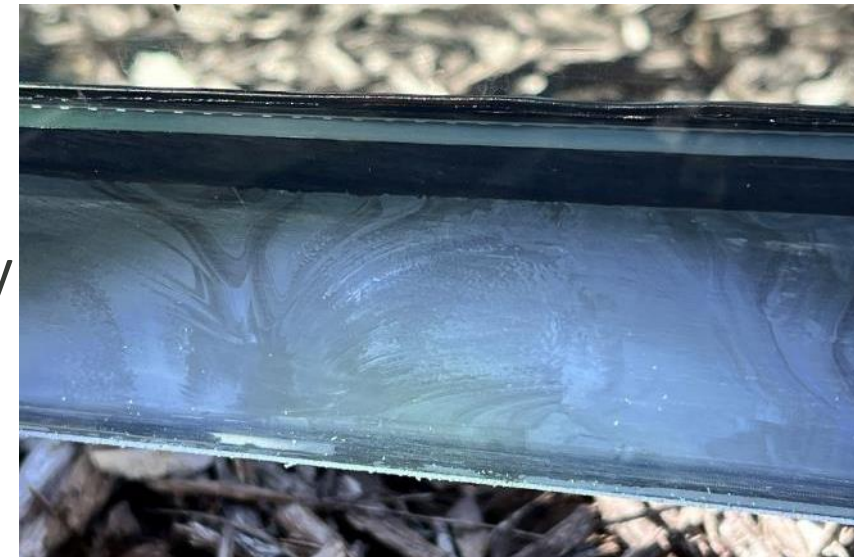
Improper
secondary
sealant
mixing

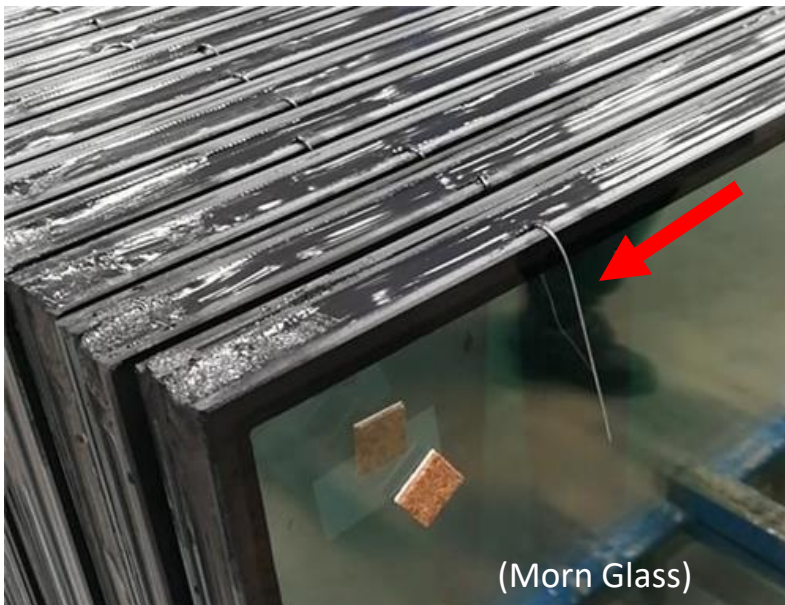
Uncrimped
capillary
tube

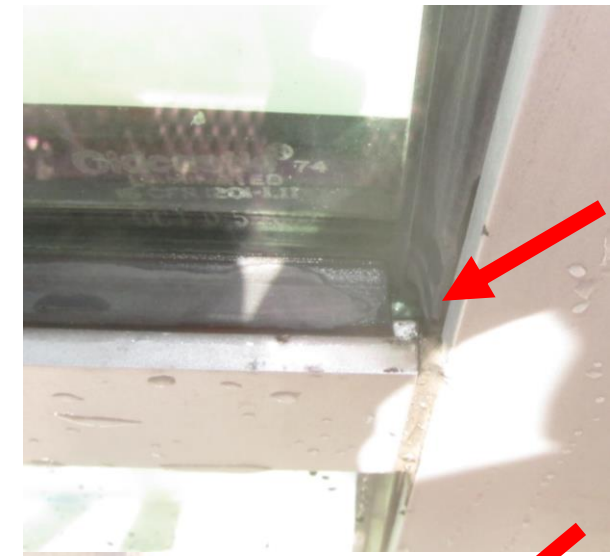
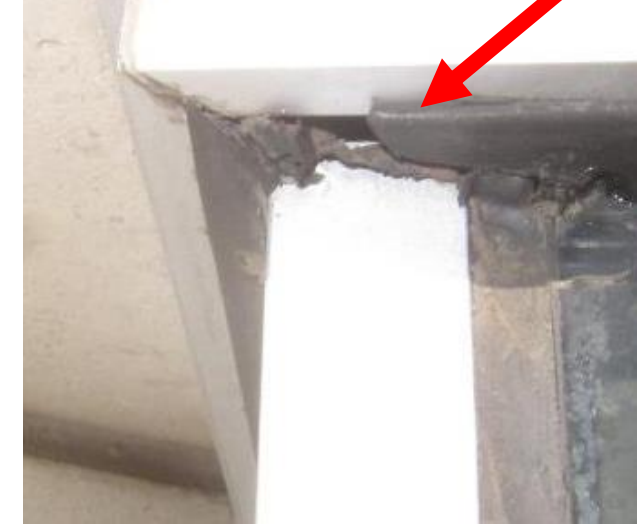
Weather Seal & Gasket Failures

- Failed sealants or loose gaskets
- Increases glass edge exposure to elements
- May result in glass-to-metal contact
- May trap water adjacent to glass edge

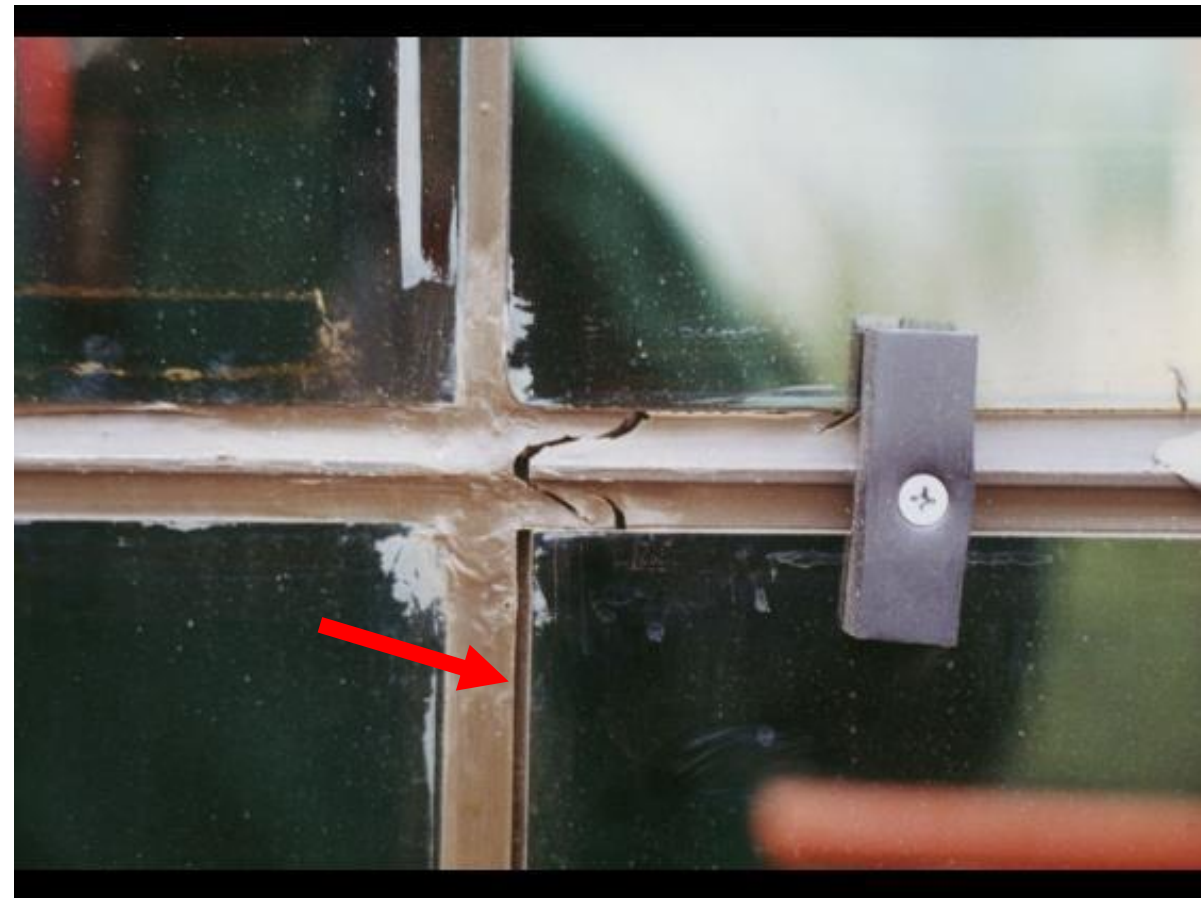
Weather Seal & Gasket Failures

- Failed sealants or loose gaskets
- Increases glass edge exposure to elements
- May result in glass-to-metal contact
- May trap water adjacent to glass edge

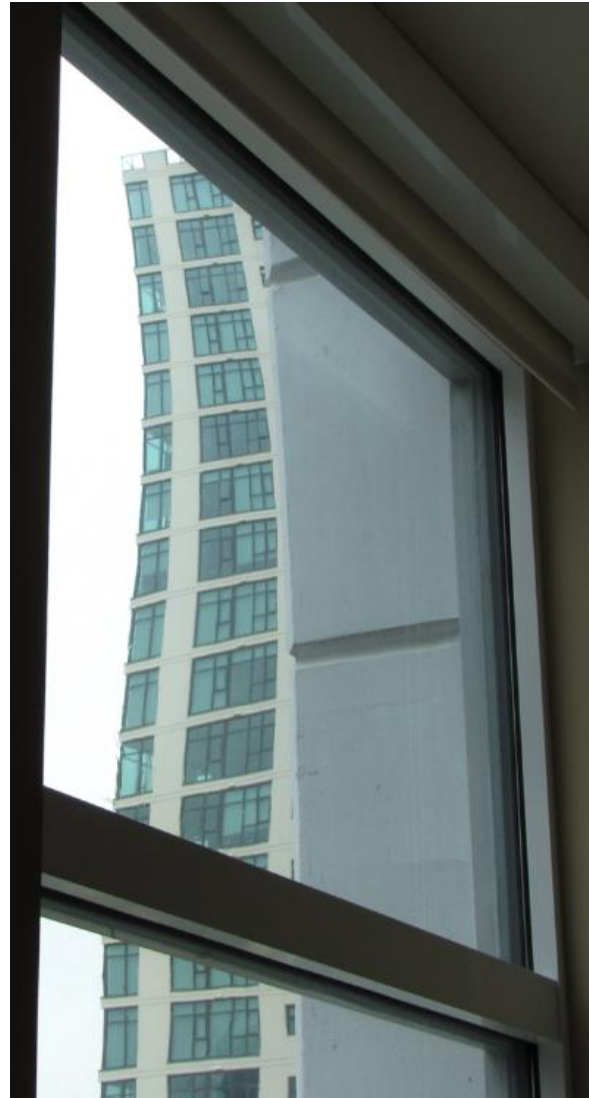
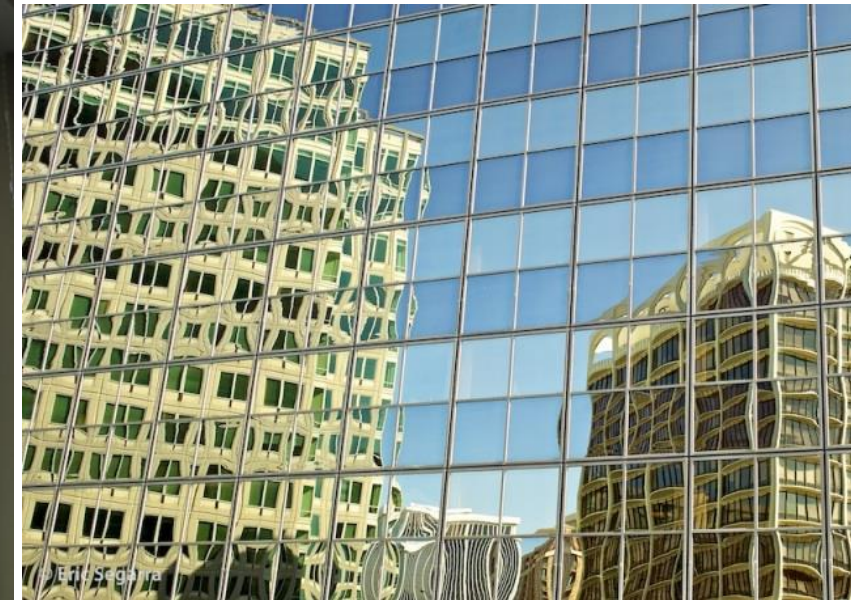
Optical Distortion

- Roller wave
- Lense effect
- Does not have an adverse effect on glass performance

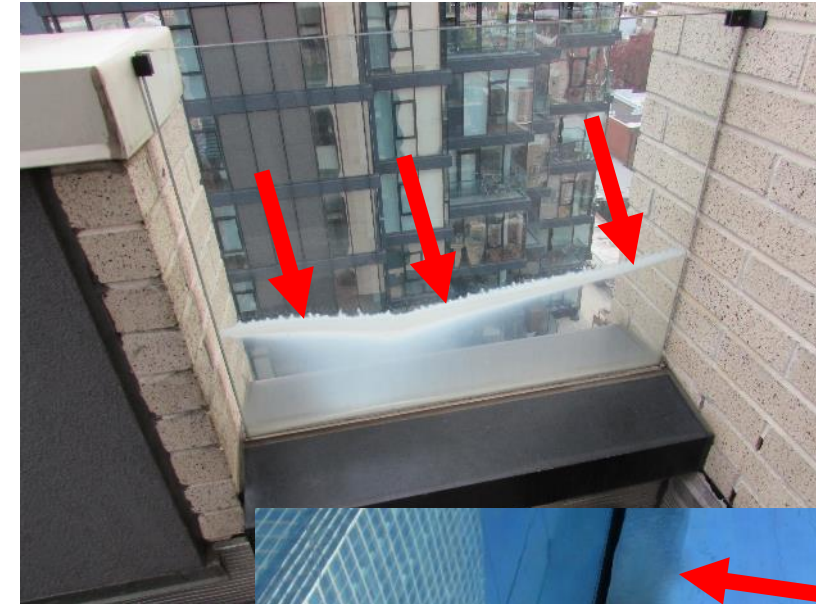
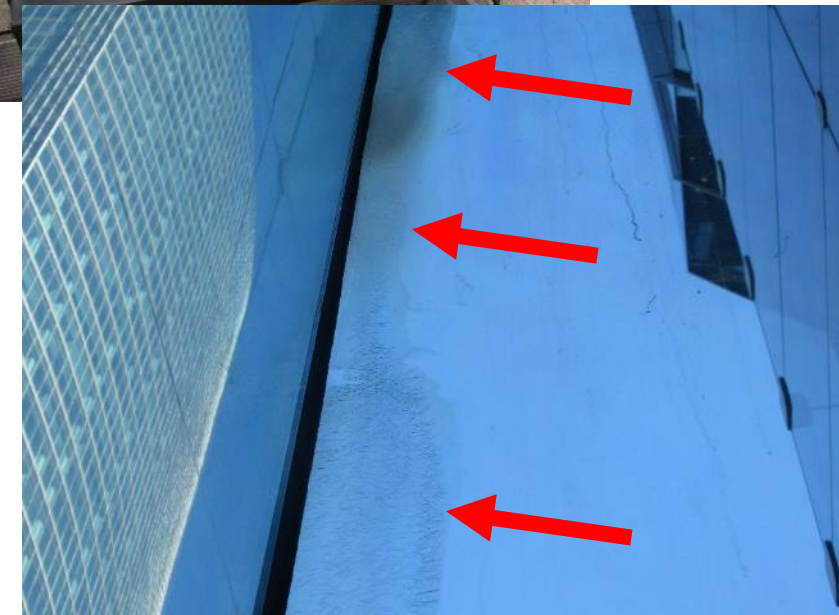
Interlayer Discoloration

- Level of apparentness varies
- May be related to incompatibility between interlayer and adjacent materials
- May be related to improper lamination
- Discoloration tends to worsen over time

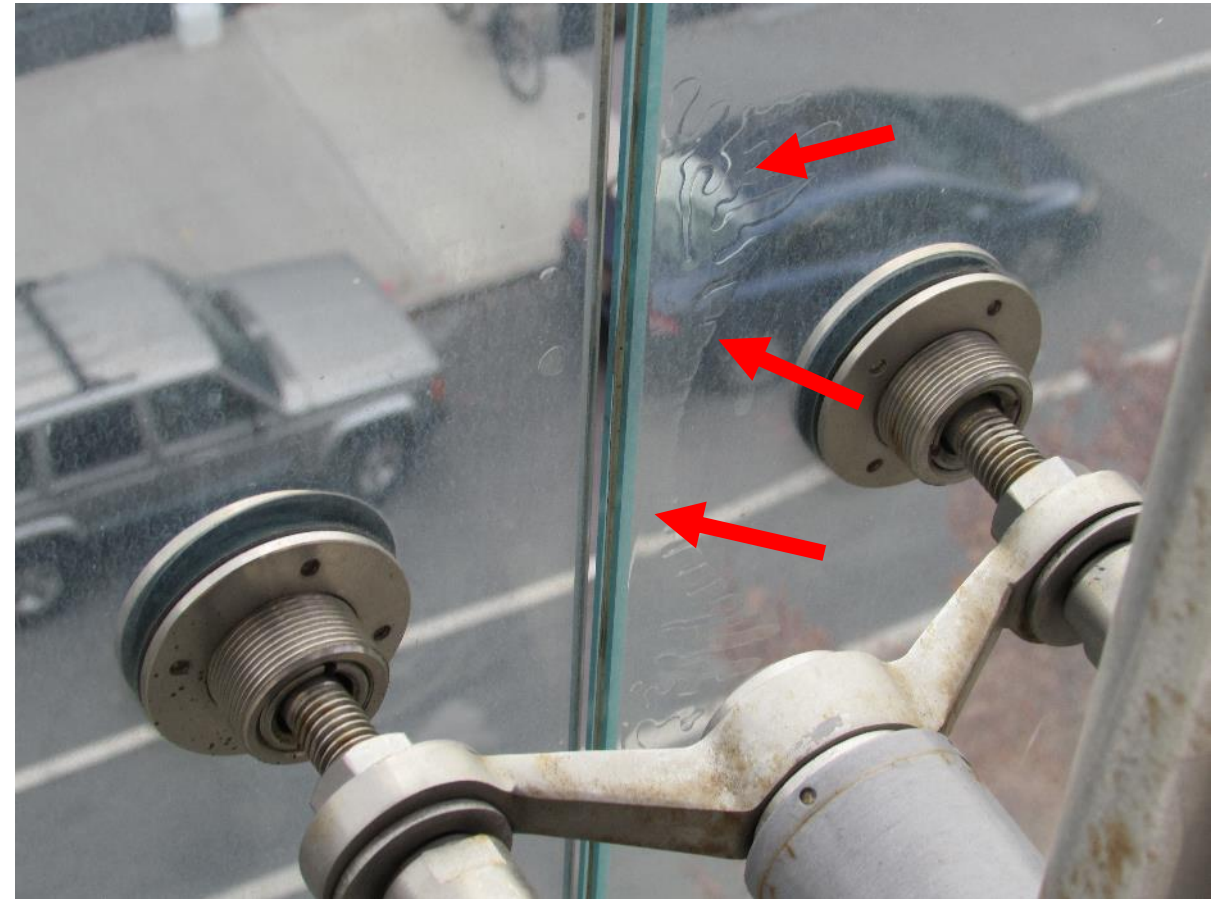
Interlayer Delamination

- Loss of bond between the interlayer and glass lite
- Typically occurs around the edge of glass
- PVB Interlayers – Appears as a fingering or burst pattern
- Ionoplast Interlayers - Smooth edges, sheen or discoloration at the delamination
